**SAMPLE REPORT**

**Inspection/Service Report**

Anonymized inspection example  
Client and property details withheld

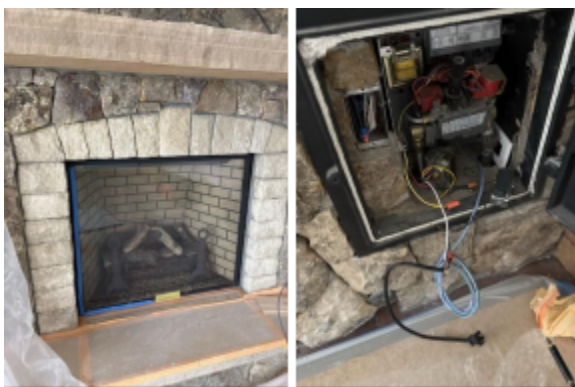
## 1.3. Primary Bedroom Fireplace – Arrival Test Fire – Deficiencies Noted

**Deficiencies noted:** Did not test fire.

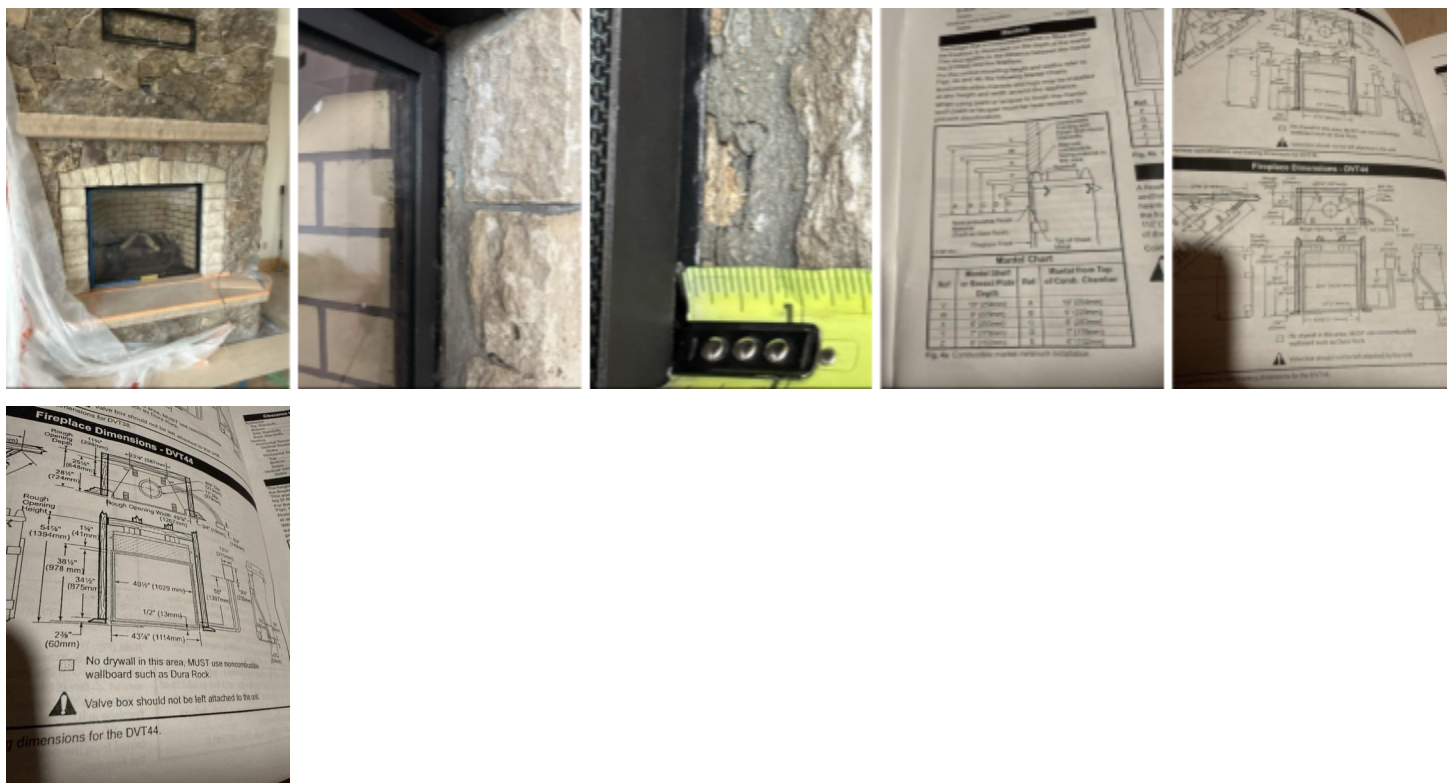
## 1.4. Primary Bedroom Fireplace – Surround Facing Materials and Fireplace Dimensions – Deficiencies Noted

**Description/Notes:** Combustible wood/OSB contacts the sides of the fireplace and extends forward of the appliance on the right side. Combustible OSB was also used at locations where the installation instructions require noncombustible facing/construction materials. The installed facing configuration therefore does not meet the applicable appliance clearance and material requirements.

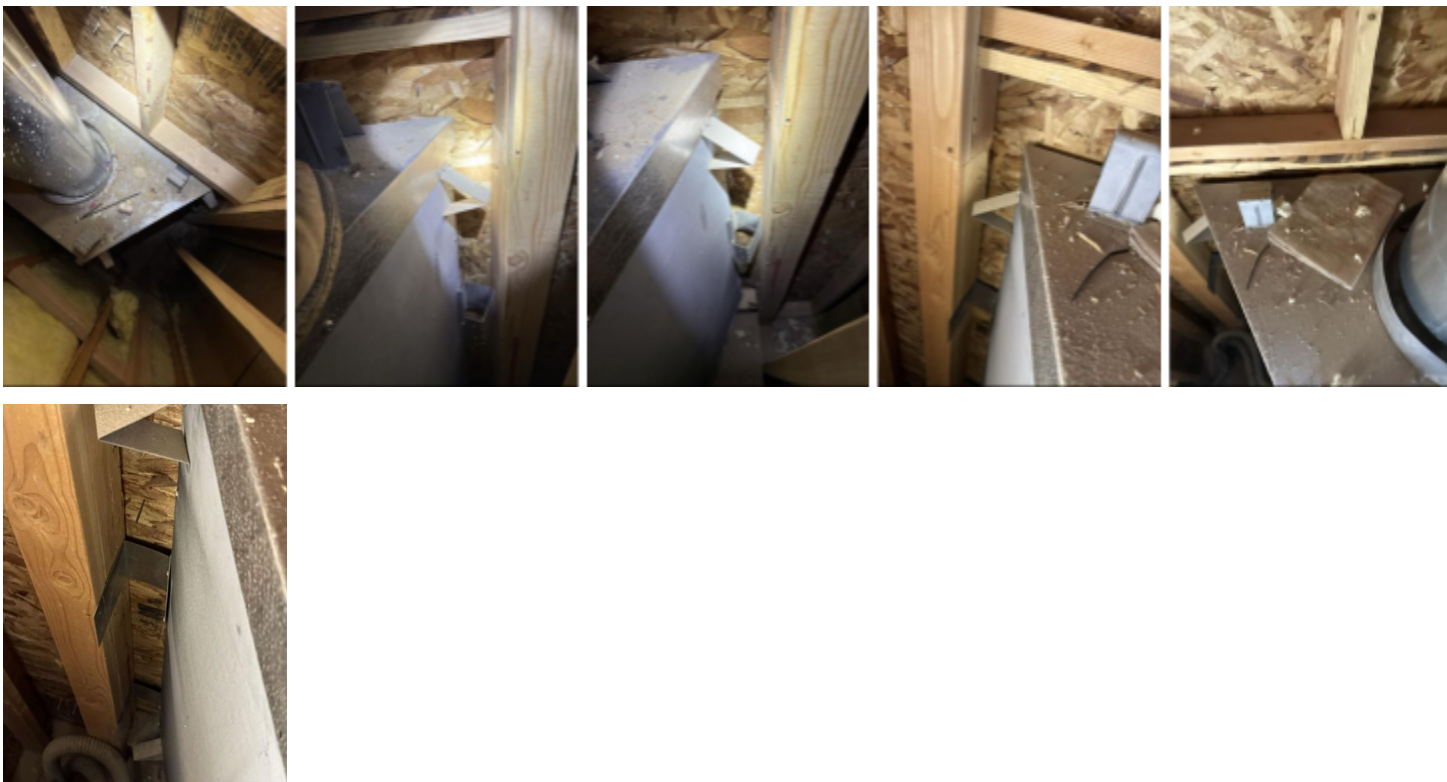
### 1.13. Primary Bedroom Fireplace – Factory-Built System Concealed in Construction – **Deficiencies Noted**

**Description/Notes:** Combustible plywood/OSB used as facing contacts the sides of the fireplace and extends downward in front of the appliance. Additional combustible materials, including the appliance manual, were stored on top of and against the fireplace at the time of inspection.

**Deficiencies noted:** Clearances Not Met.

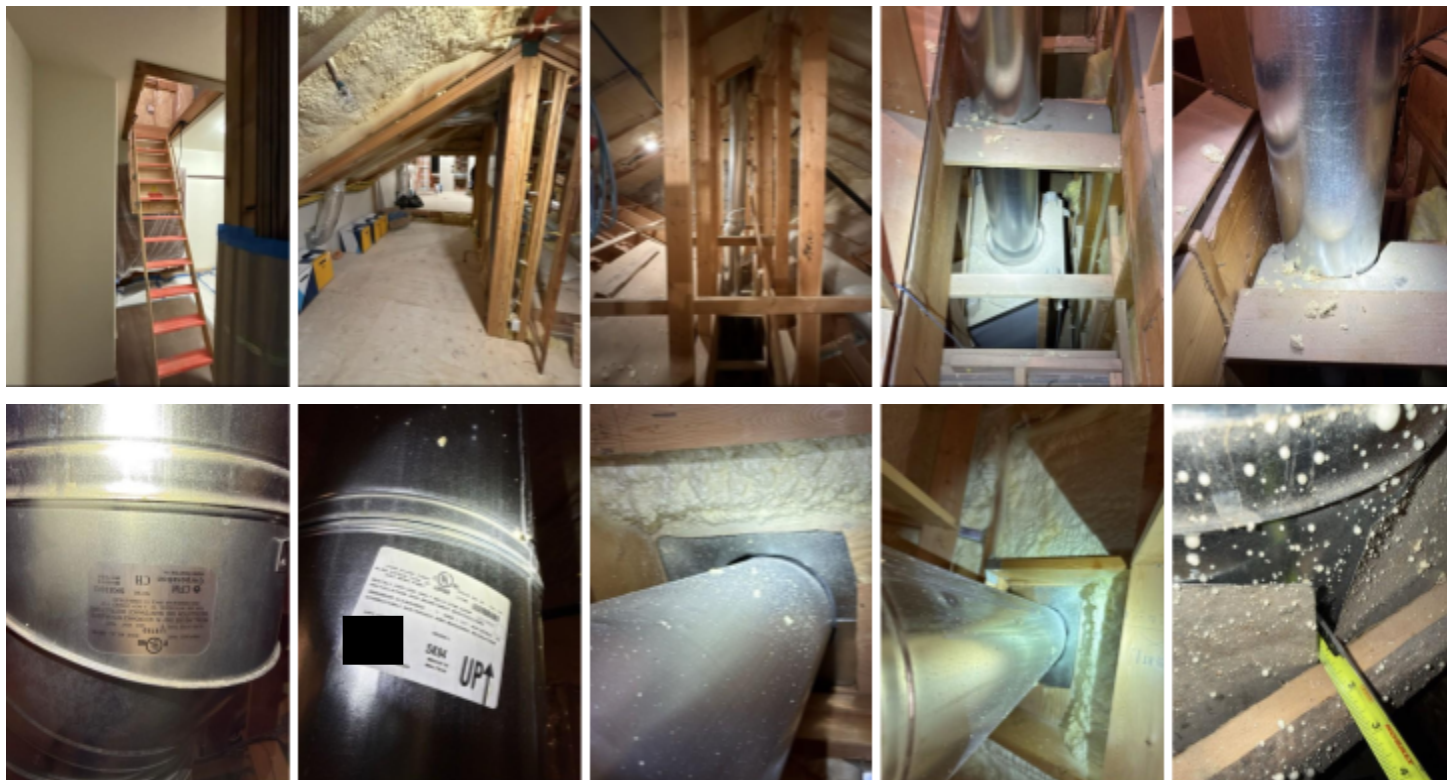
**1.14. Primary Bedroom Fireplace – Factory-Built Chimney/Vent in Adjoining Areas – Deficiencies Noted**

**Description/Notes:** Required vent clearances are not maintained in the accessible attic area. A loose 2x6 framing member is in contact with the vent, and spray-foam insulation is adhered to portions of the vent along the accessible run.

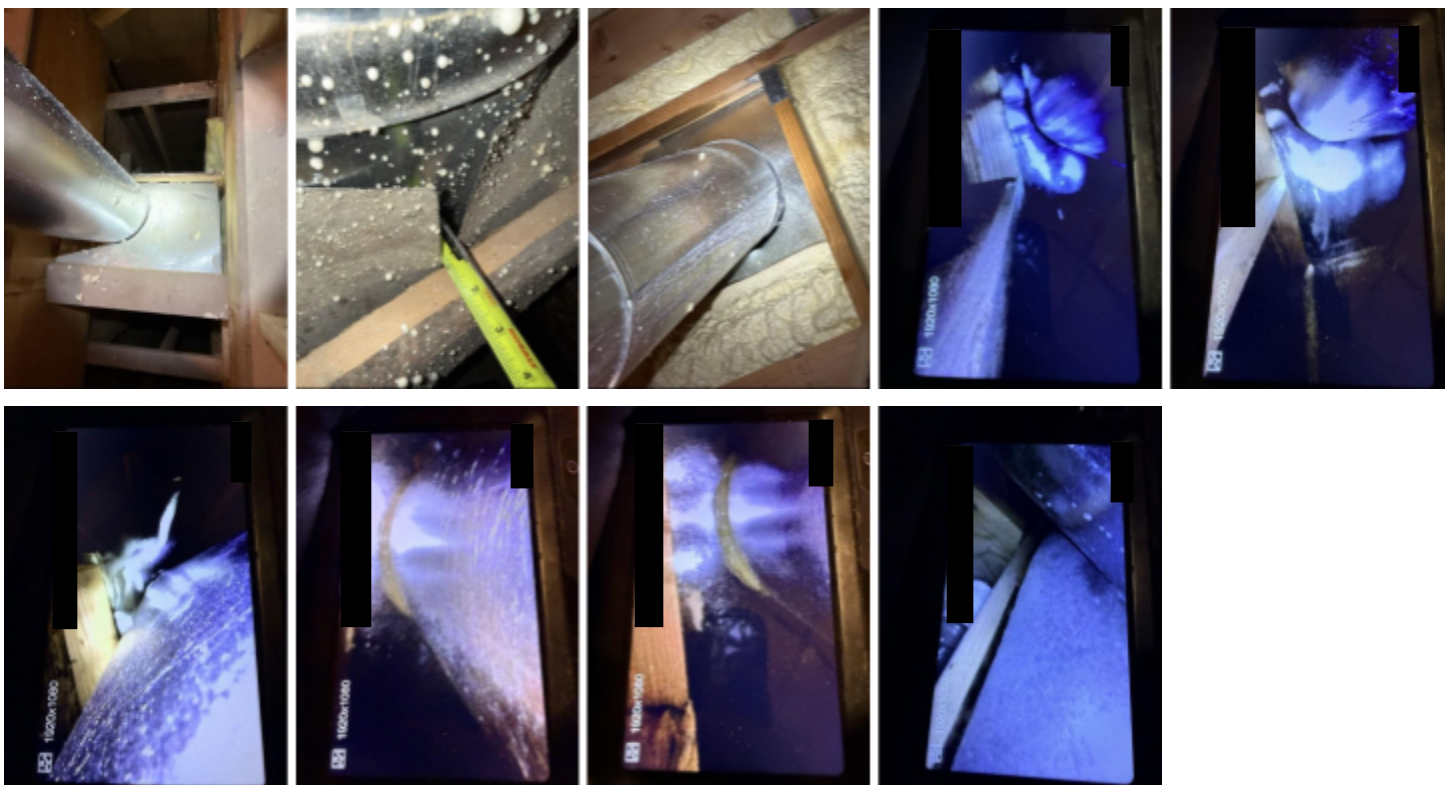
### 1.15. Primary Bedroom Fireplace – Firestop Spacers and Radiation Shields – **Deficiencies Noted**

**Description/Notes:** Firestop components are present at the roof/chase transition and at the lower penetration; however, the lower firestop is not installed in the required configuration and does not maintain the intended spacing around the vent.

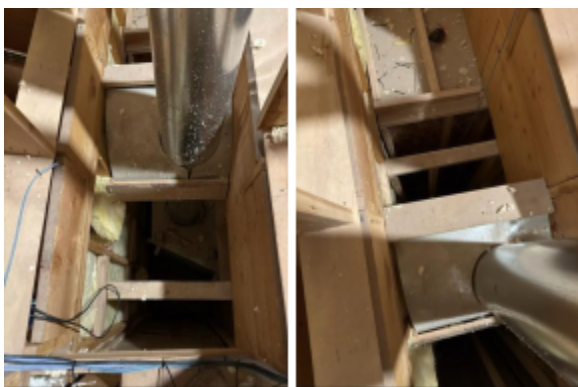
### 1.16. Primary Bedroom Fireplace – Fireblocking – **Deficiencies Noted**

**Description/Notes:** Fire blocking is incomplete and the Chase is open into the attic.

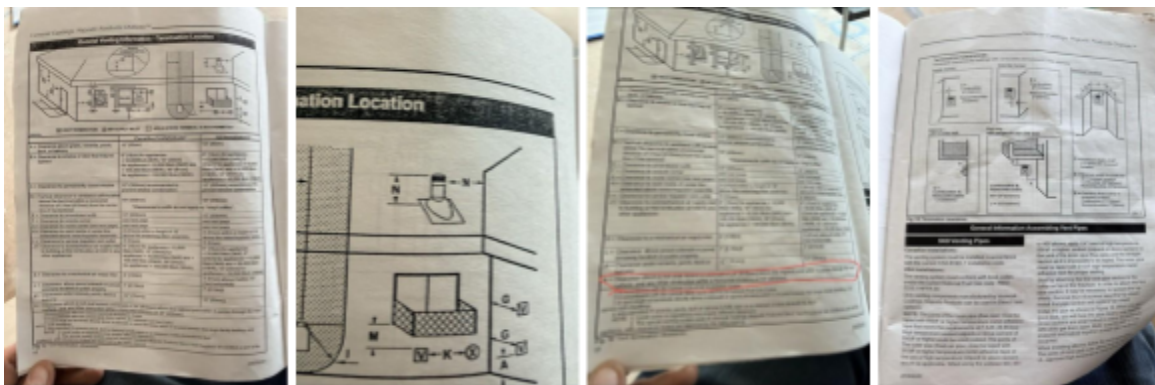
### 1.18. Primary Bedroom Fireplace – Factory-Built Chimney/Vent Termination – **Deficiencies Noted**

**Description/Notes:** The DVT44 installation instructions require the vertical termination to extend a minimum of 24 inches above the highest point where the vent penetrates the roof. The existing termination height does not meet that requirement. The manufacturer also identifies specific listed components for terminating the vent at or through a chase; any corrected termination should use a documented listed/approved DVT44/SK8 configuration.

Selection of the replacement appliance should also include evaluation of its complete listed venting and chase-top termination system. Because the existing termination is incorporated into a field-built stone enclosure, the replacement appliance should not be selected until a documented termination configuration compatible with the intended exterior finish has been established.

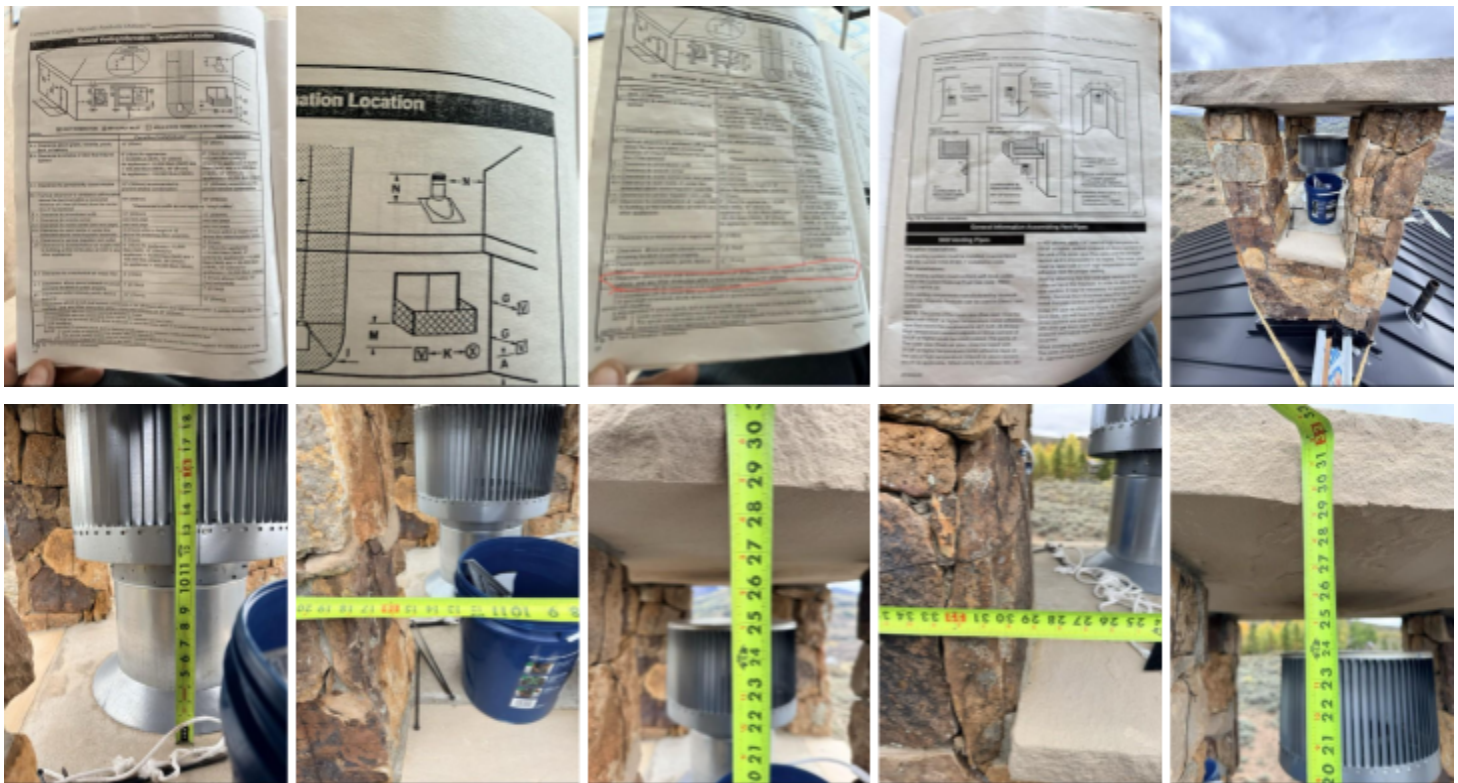
### 1.19. Primary Bedroom Fireplace – Shrouds – **Deficiencies Noted**

**Description/Notes:** The existing vent termination is located within a field-built stone enclosure. The DVT44 instructions provide specific listed SK8 chase-top termination components, including an extended round-top termination and dedicated chase-top housings. The existing field-built configuration does not match one of the documented listed chase-top arrangements.

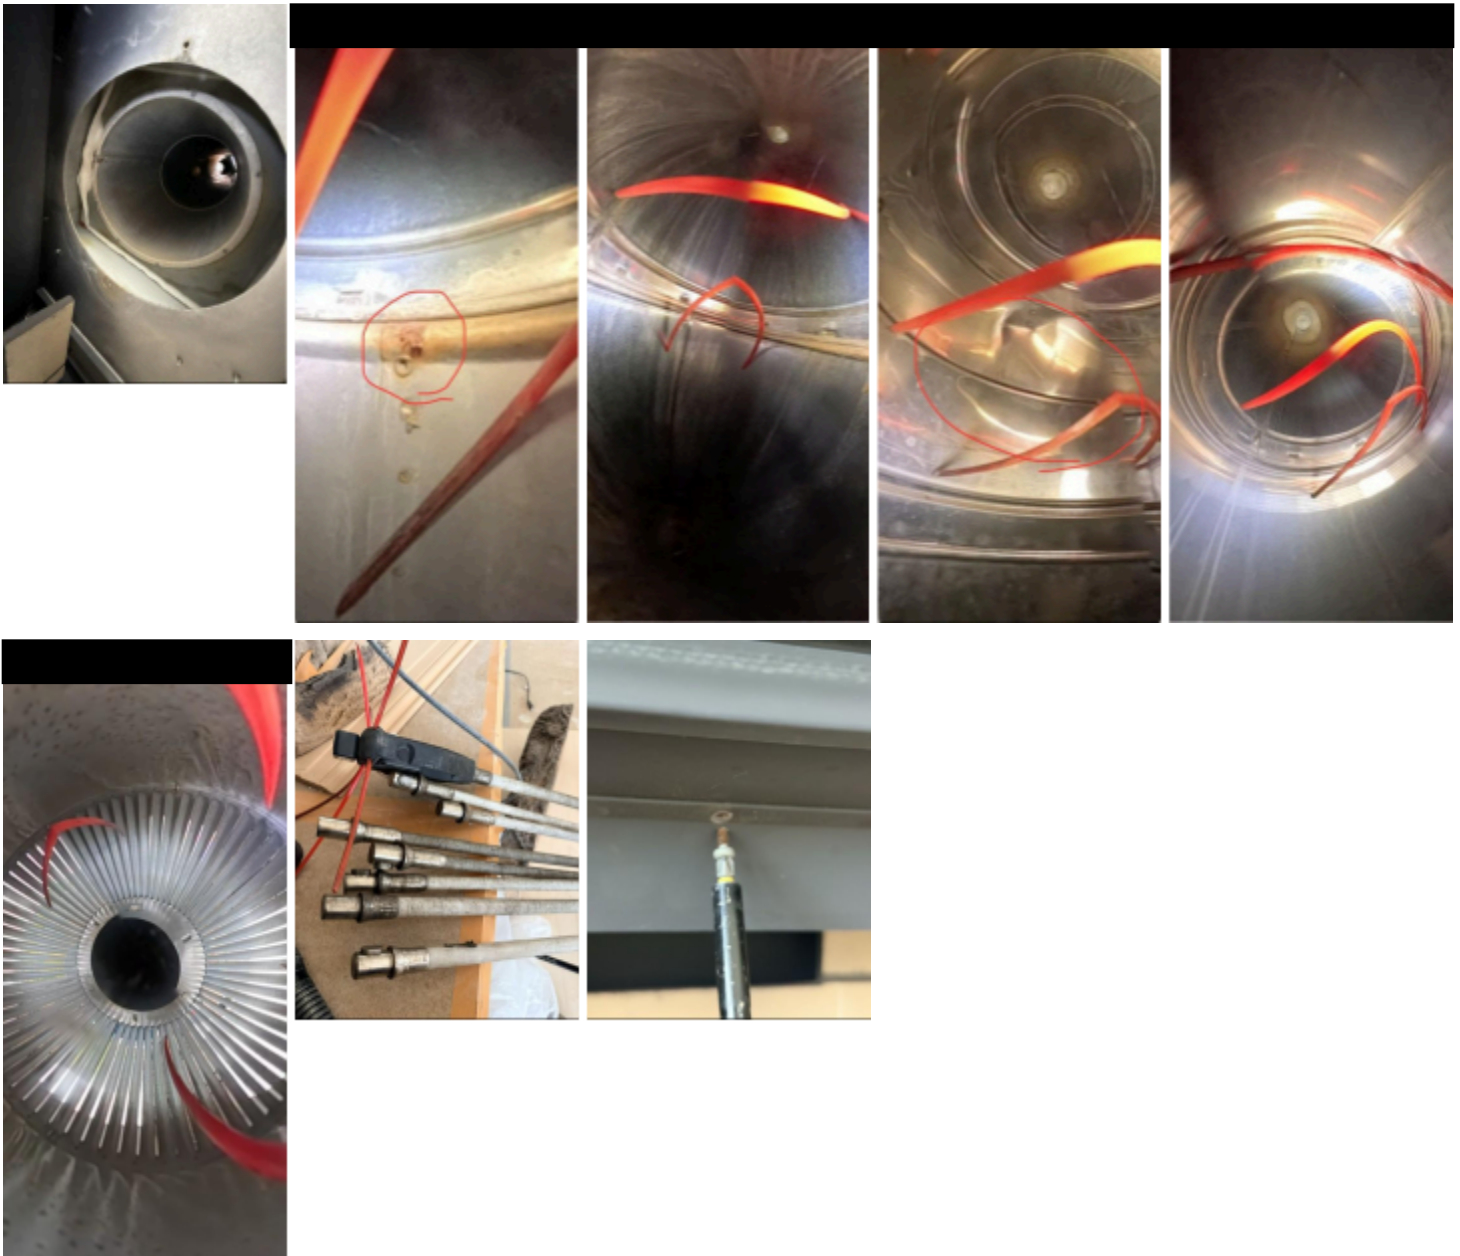
## 1.20. Primary Bedroom Fireplace – Factory Built Flue Interior – Deficiencies Noted

**Description/Notes:** Some rust has started forming at some seams. This was also indicated by the screws removed inside the top of the fire box. They're showing signs of rust in the outer layers of the sheetmetal fireplace as well. This indicates Water or moisture has entered the outer layer of the system. There was also a portion of the elbow that was warped and rippled.

Discontinue use. Replacement of the Majestic/Vermont Castings DVT44 fireplace and its compatible listed venting system is recommended. The vent system shows moisture-related corrosion and deformation in addition to clearance, firestop/fireblocking, facing, and termination deficiencies. Current parts research also indicates that multiple critical model-specific components are discontinued or unavailable. If repair is nevertheless considered, a qualified hearth contractor should first verify the condition of the appliance chassis, identify every affected vent component, and establish that exact listed replacement components remain available. Correcting only the roof termination would not address the deficiencies documented elsewhere in the system. The completed replacement or corrective work should be reinspected before operation.

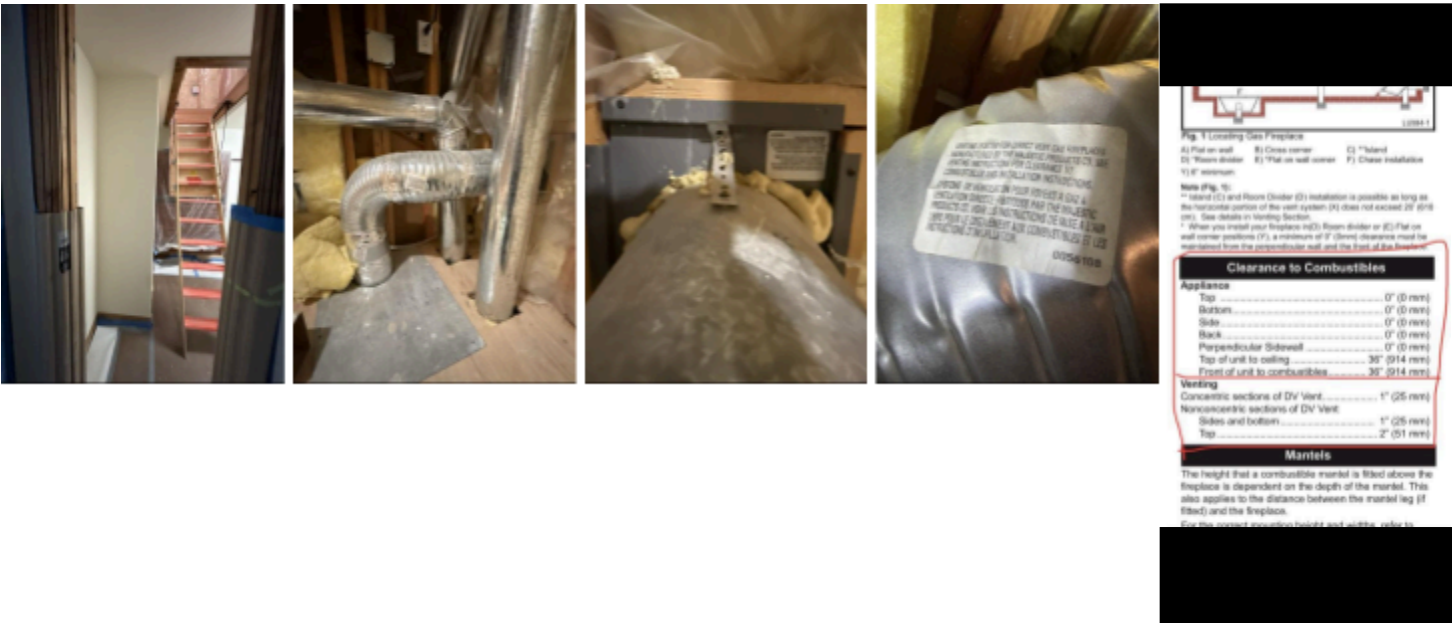
2.14. Primary Bathroom Fireplace – Factory-Built Chimney/Vent in Adjoining Areas – Deficiencies Noted

**Description/Notes:** Clearances were not met where piping comes through the floor penetration and expanding foam was used around the termination inside the wall thimble.

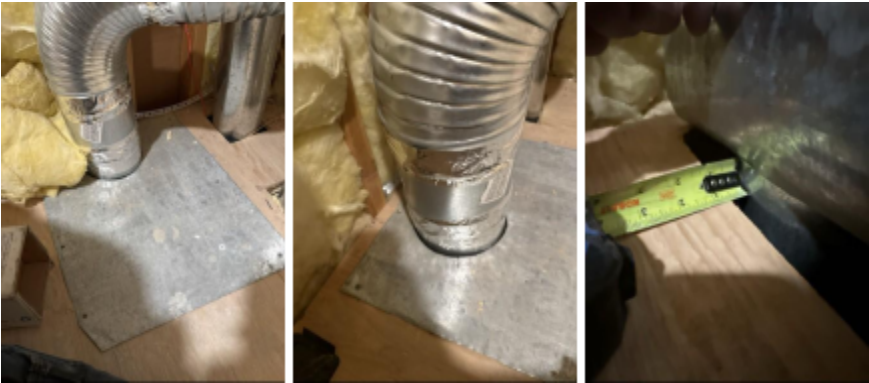
2.15. Primary Bathroom Fireplace – Firestop Spacers and Radiation Shields – Deficiencies Noted

**Deficiencies noted:** Other Issue.

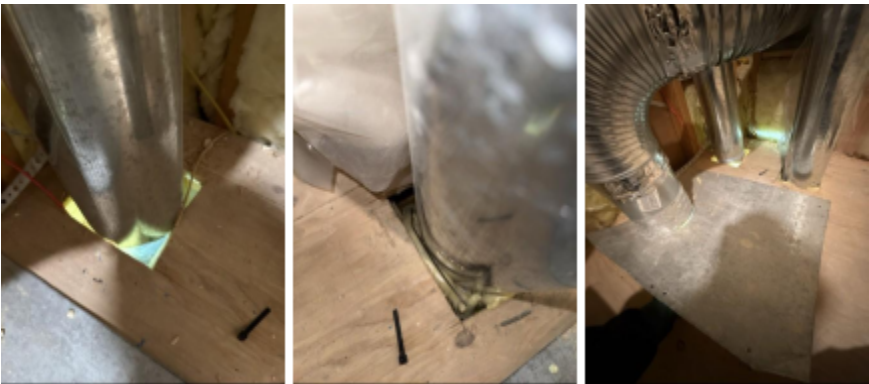
2.16. Primary Bathroom Fireplace – Fireblocking – **Deficiencies Noted**

**Deficiencies noted:** Component/materials Missing, Improperly Constructed/supported.

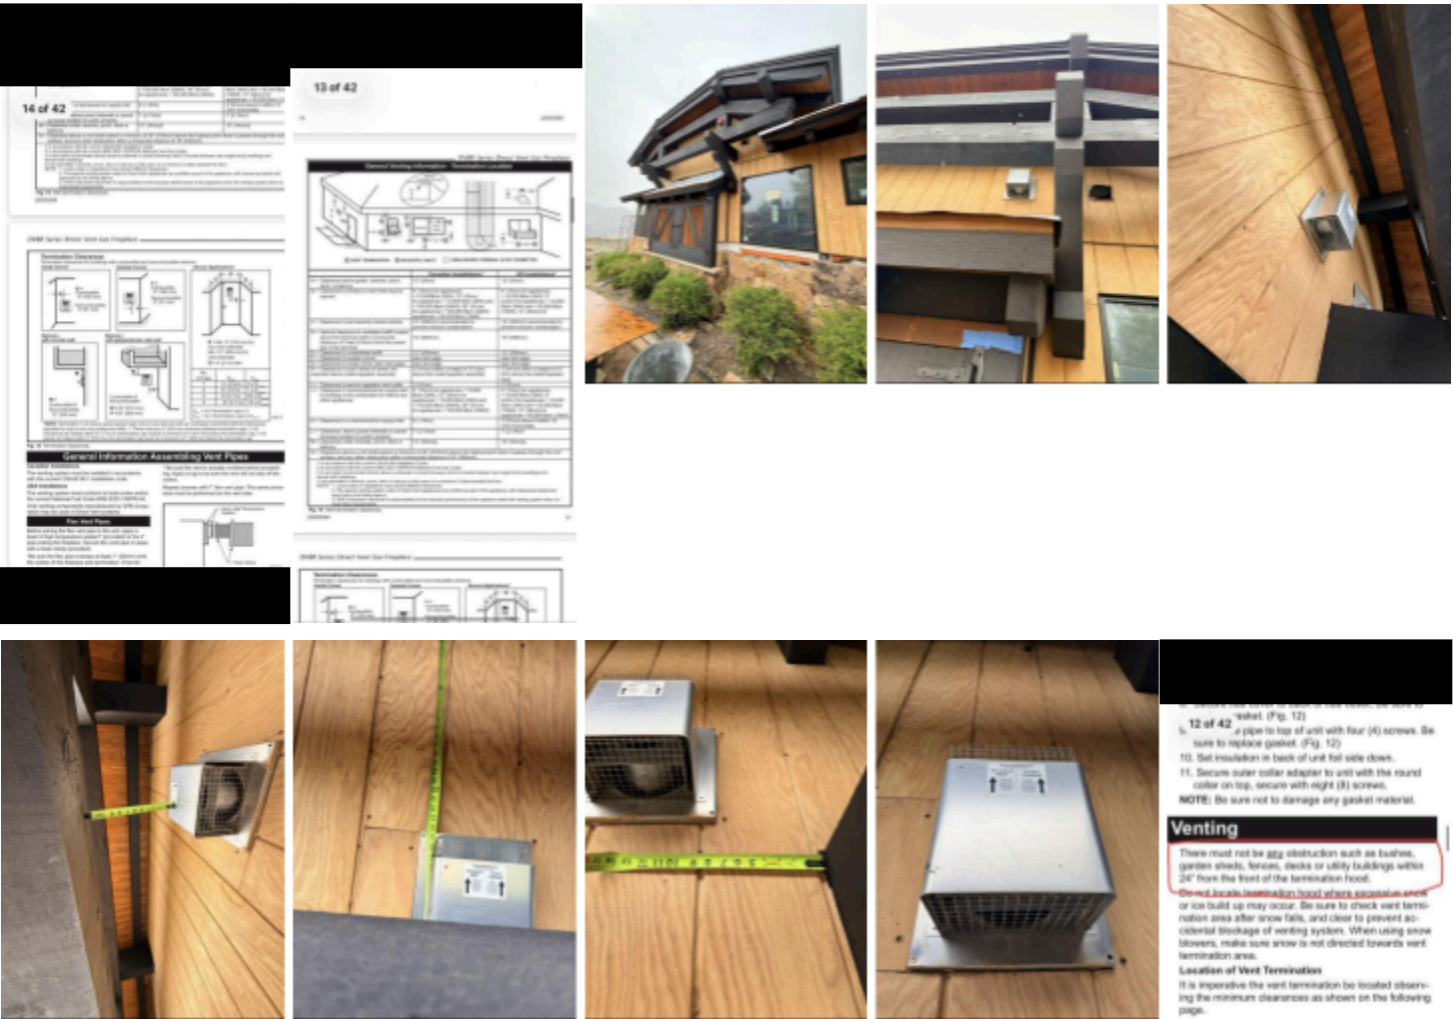
2.17. Primary Bathroom Fireplace – Factory-Built Chimney/Vent Termination – **Deficiencies Noted**

**Description/Notes:** The exterior termination does not have the required unobstructed area in front of the termination hood. The manufacturer requires a minimum 24-inch clearance in front of the termination. The existing architectural projection is located within that required clear space.

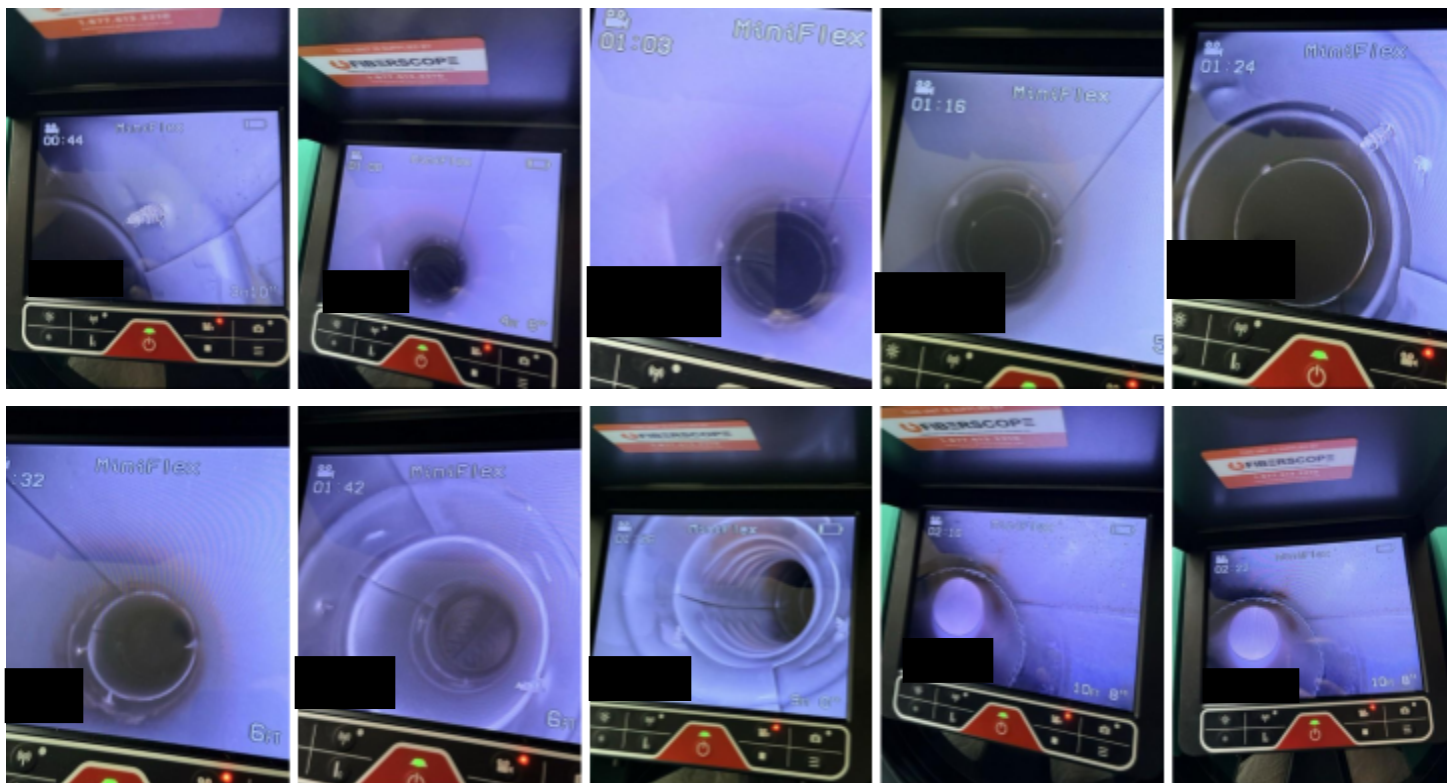
## 2.18. Primary Bathroom Fireplace – Factory Built Flue Interior – Deficiencies Noted

**Description/Notes:** Fasteners penetrate the inner vent liner at multiple joints/seams throughout the accessible vent run. This condition was repeatedly observed during the internal camera inspection.

Discontinue use pending correction. Replacement of the fireplace and its complete listed direct-vent system is favored. Although the appliance operated during the limited test fire, the proprietary vent system contains repeated inner-liner fastener penetrations, clearance/firestop deficiencies, and an obstructed exterior termination. A repair may remain possible only if a qualified hearth contractor can document the complete vent route, replace every damaged or nonconforming vent component with exact listed components, correct all penetration/fireblocking and termination conditions, and verify the completed system. Because the DVBR36 is a legacy appliance with limited model-specific parts availability, the feasibility and long-term value of such repair should be established before work begins. Reinspection is recommended before use.

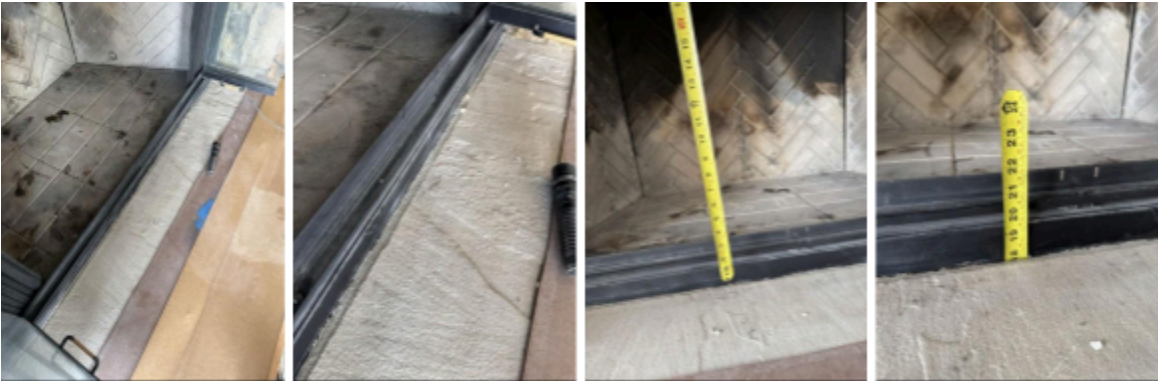
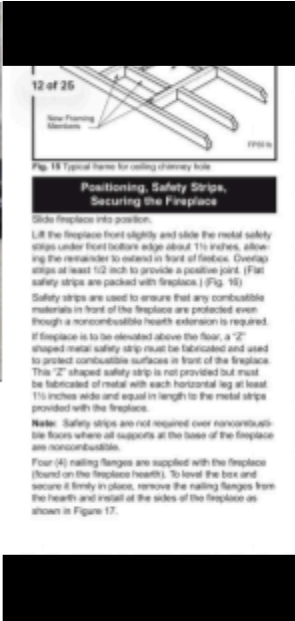
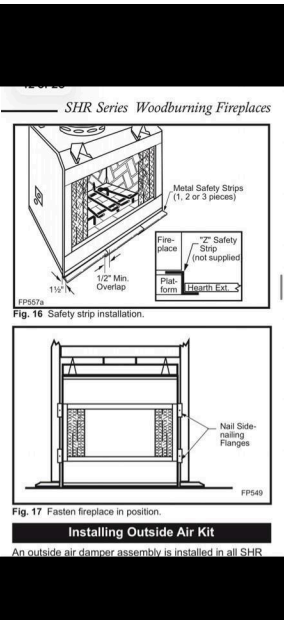
3.5. Main Level Great Room Fireplace – Spark/Z-Strip – Deficiencies Noted

Deficiencies noted: Component Missing.

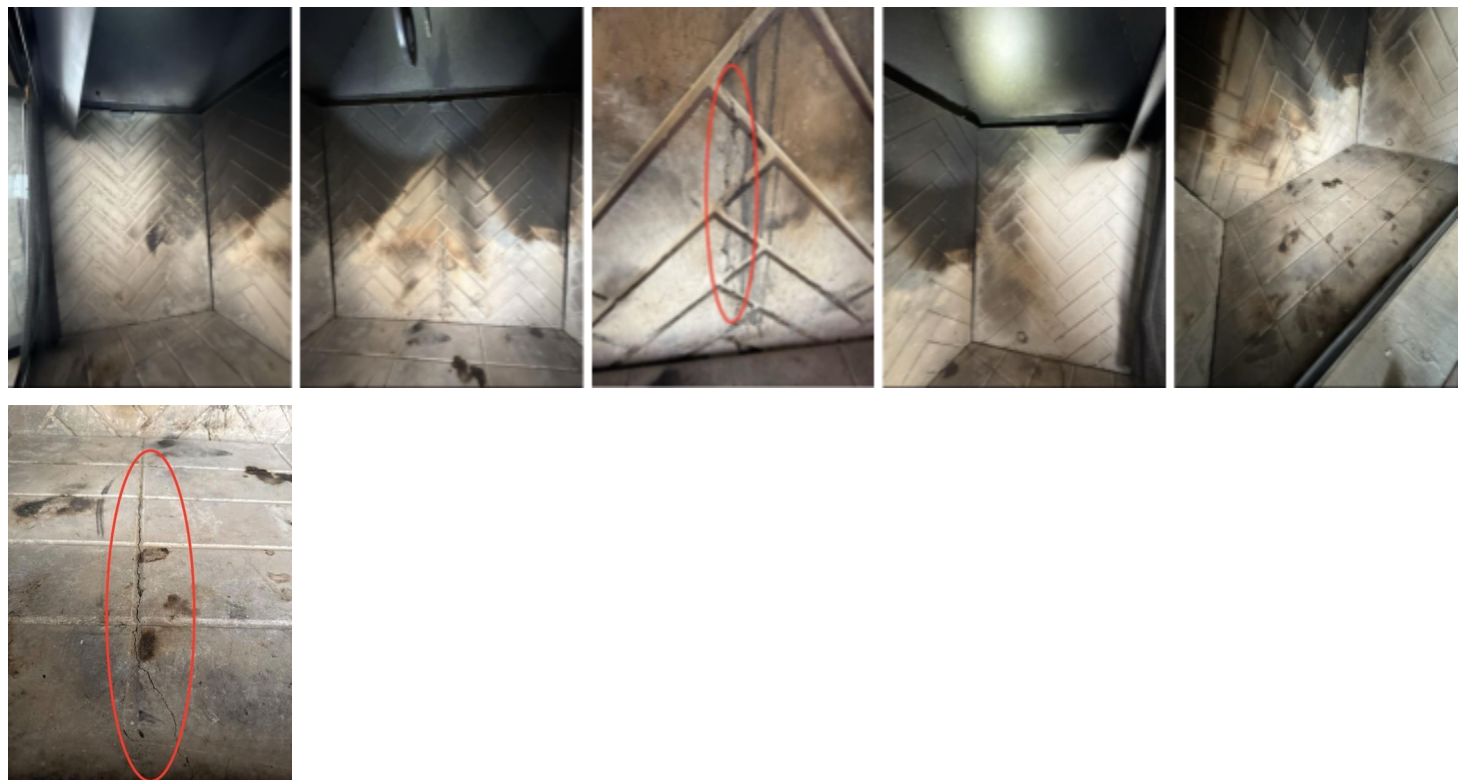
3.7. Main Level Great Room Fireplace – Firebox and Internal Components – Deficiencies Noted

**Description/Notes:** Rear and hearth/base refractory panels are cracked and broken.

Discontinue use. Replacement of the SHR52 fireplace with a currently listed fireplace and its compatible chimney system is recommended. The existing fireplace has a missing hearth safety strip, damaged proprietary refractory, a malfunctioning damper, disconnected outside-combustion-air components, incomplete fireblocking, and unresolved chase/termination deficiencies. Current parts research indicates that several components directly implicated by the inspection findings, including the damper assembly and multiple refractory panels, are discontinued.

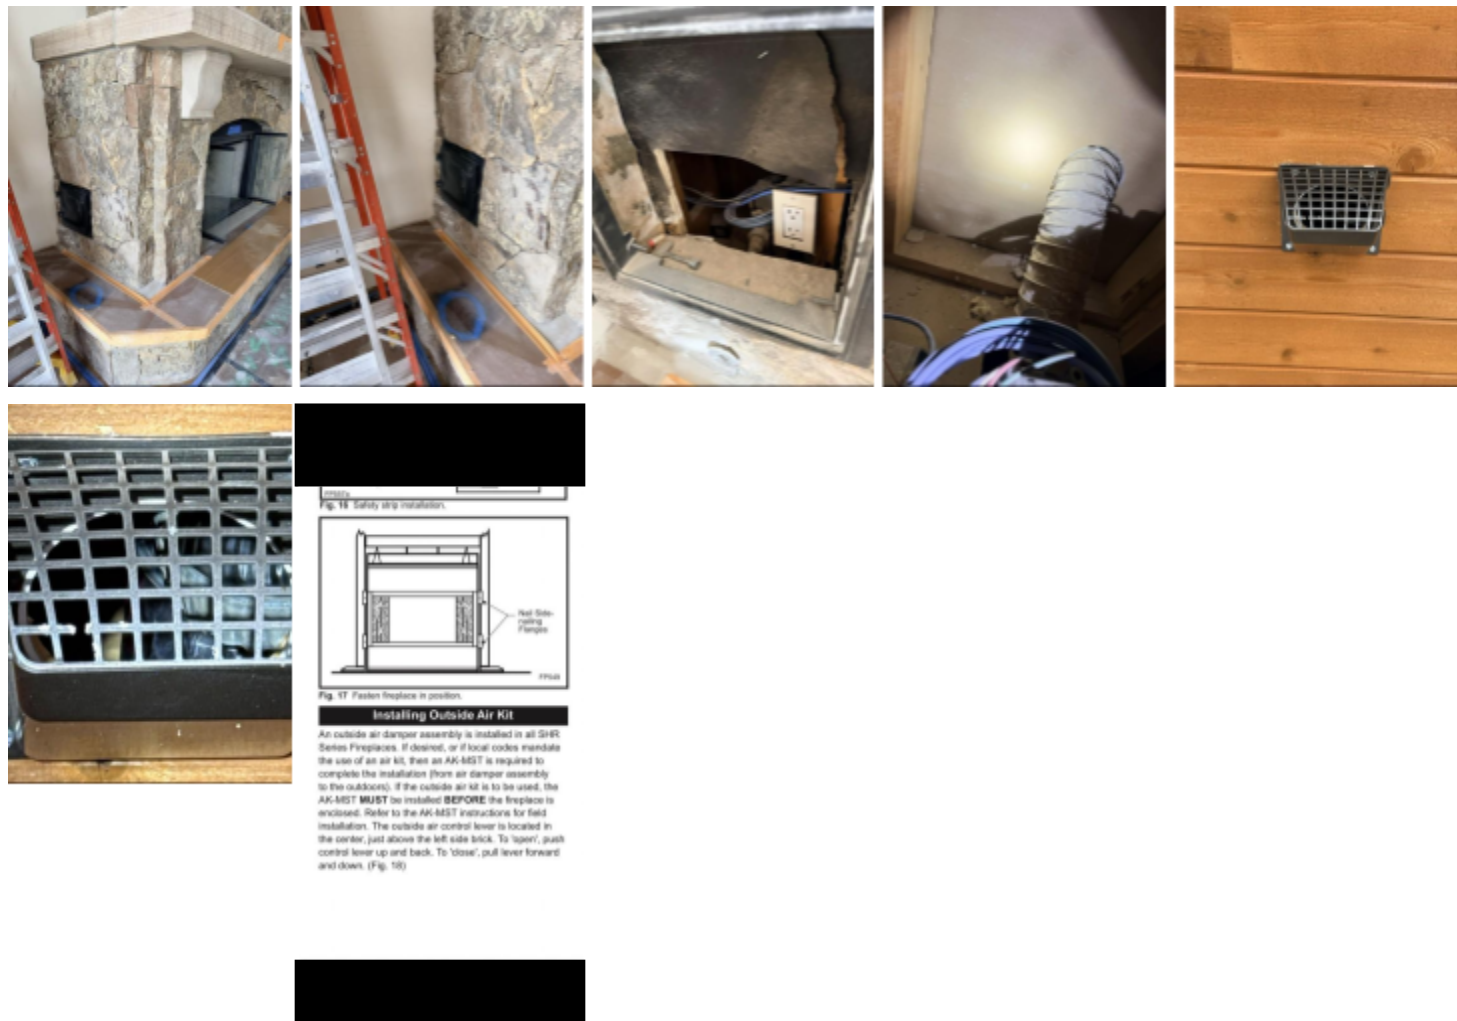
3.8. Main Level Great Room Fireplace – Combustion Air System – Deficiencies Noted

**Description/Notes:** The fireplace outside-combustion-air system routes from the fireplace through the building to exterior terminations. Portions of this duct system have been disconnected during the ongoing renovation. One duct is disconnected at the exterior termination, and another was observed disconnected near the fireplace/chase. The contractor reported that portions are intended to be reconnected.

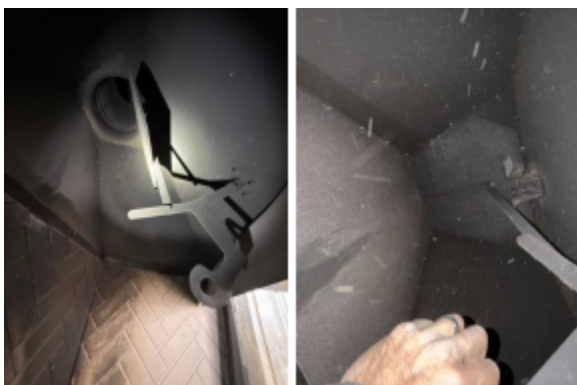
### 3.10. Main Level Great Room Fireplace – Dampers and Controls – **Deficiencies Noted**

**Description/Notes:** Damper does not stay closed unless held in place.

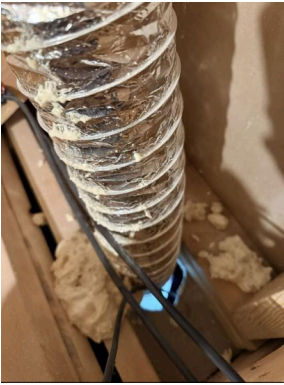
### 3.16. Main Level Great Room Fireplace – Fireblocking – **Deficiencies Noted**

**Description/Notes:** Immediately around the outside combustion air duct penetrations... there is an opening.

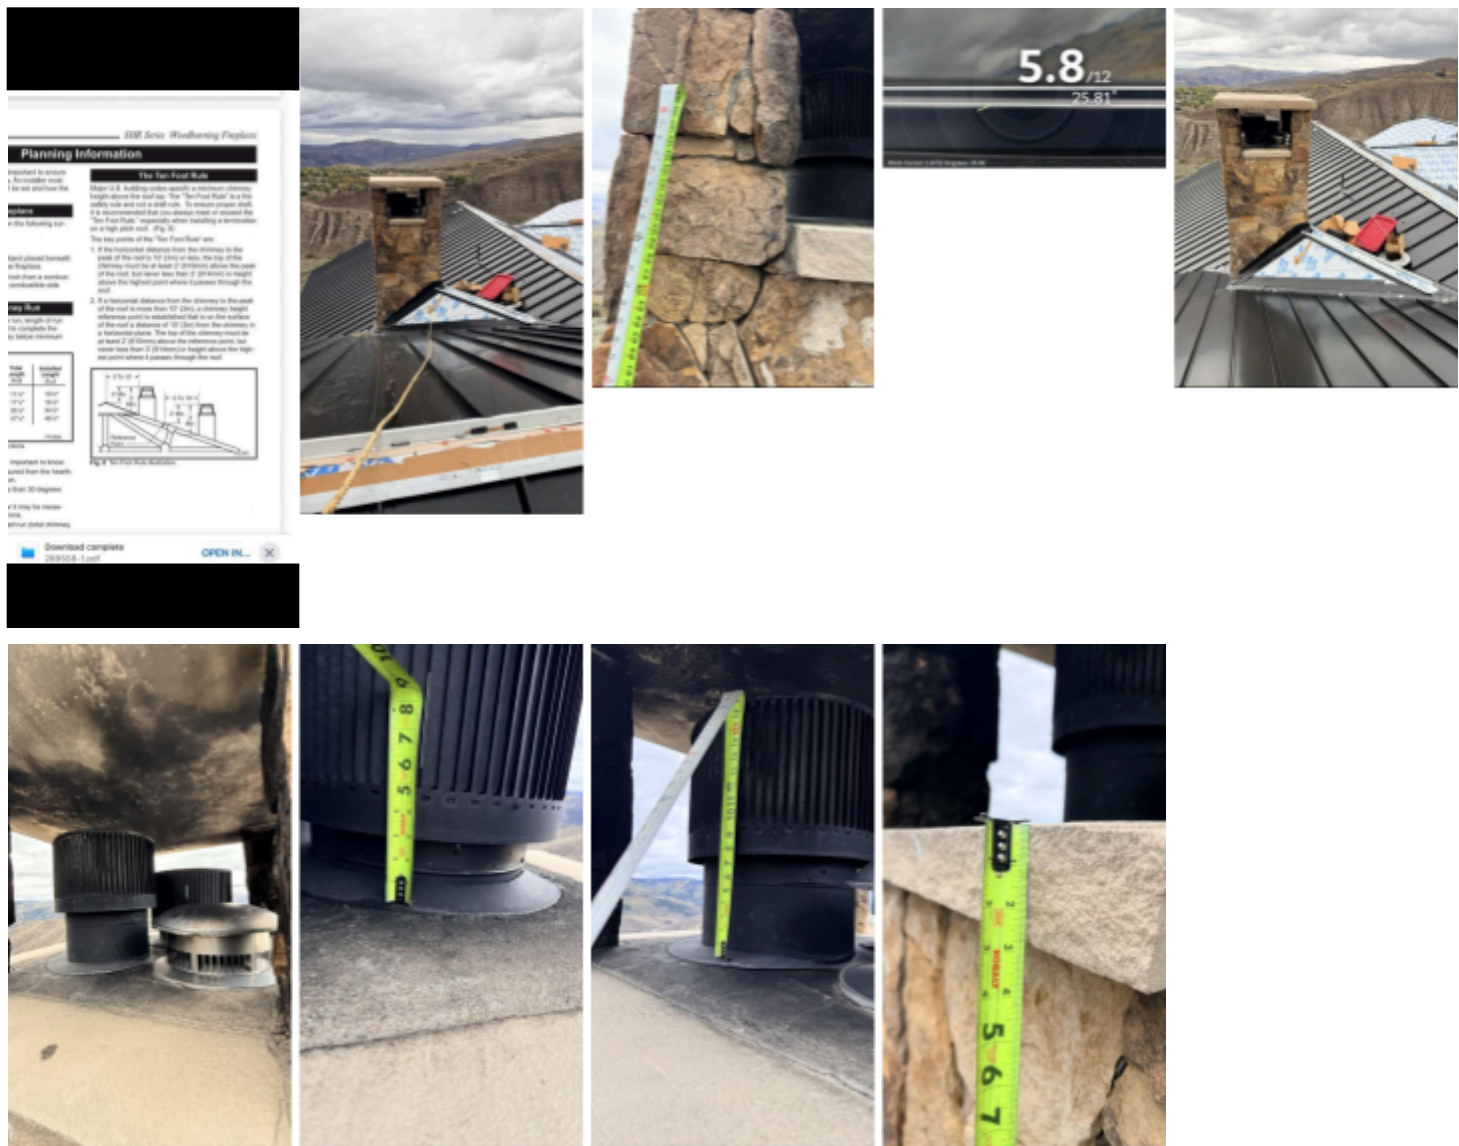
### 3.18. Main Level Great Room Fireplace – Factory-Built Chimney/Vent Termination – **Deficiencies Noted**

**Description/Notes:** The Type 11CF chimney satisfies the applicable overall minimum termination height above the roof and the manufacturer's Ten Foot Rule based on field measurements. The chimney terminates within a shared field-built stone chase/enclosure. The manufacturer's separate termination instructions require chimney tops installed within one enclosure to be spaced a minimum of 21 inches on center. The observed spacing between this termination and the adjacent chimney termination(s) is less than the required 21-inch minimum; an exact center-to-center dimension was not obtained during the inspection.

The shared stone chase and termination configuration should be evaluated before a replacement fireplace is selected. The present Type 11CF terminations do not provide the manufacturer's required 21-inch center-to-center spacing within the shared enclosure, and the custom stone crown is not a documented listed shroud configuration. A replacement appliance should therefore be selected together with a complete chimney and termination system that can be installed within the available chase geometry using documented approved components. If coordinated replacement systems can use compatible listed chase-top termination methods, reconstruction may be simplified. The existing stone crown should not be assumed suitable for reuse unless specifically permitted by the replacement-system manufacturer. Reinspection of the completed installation is recommended before operation.

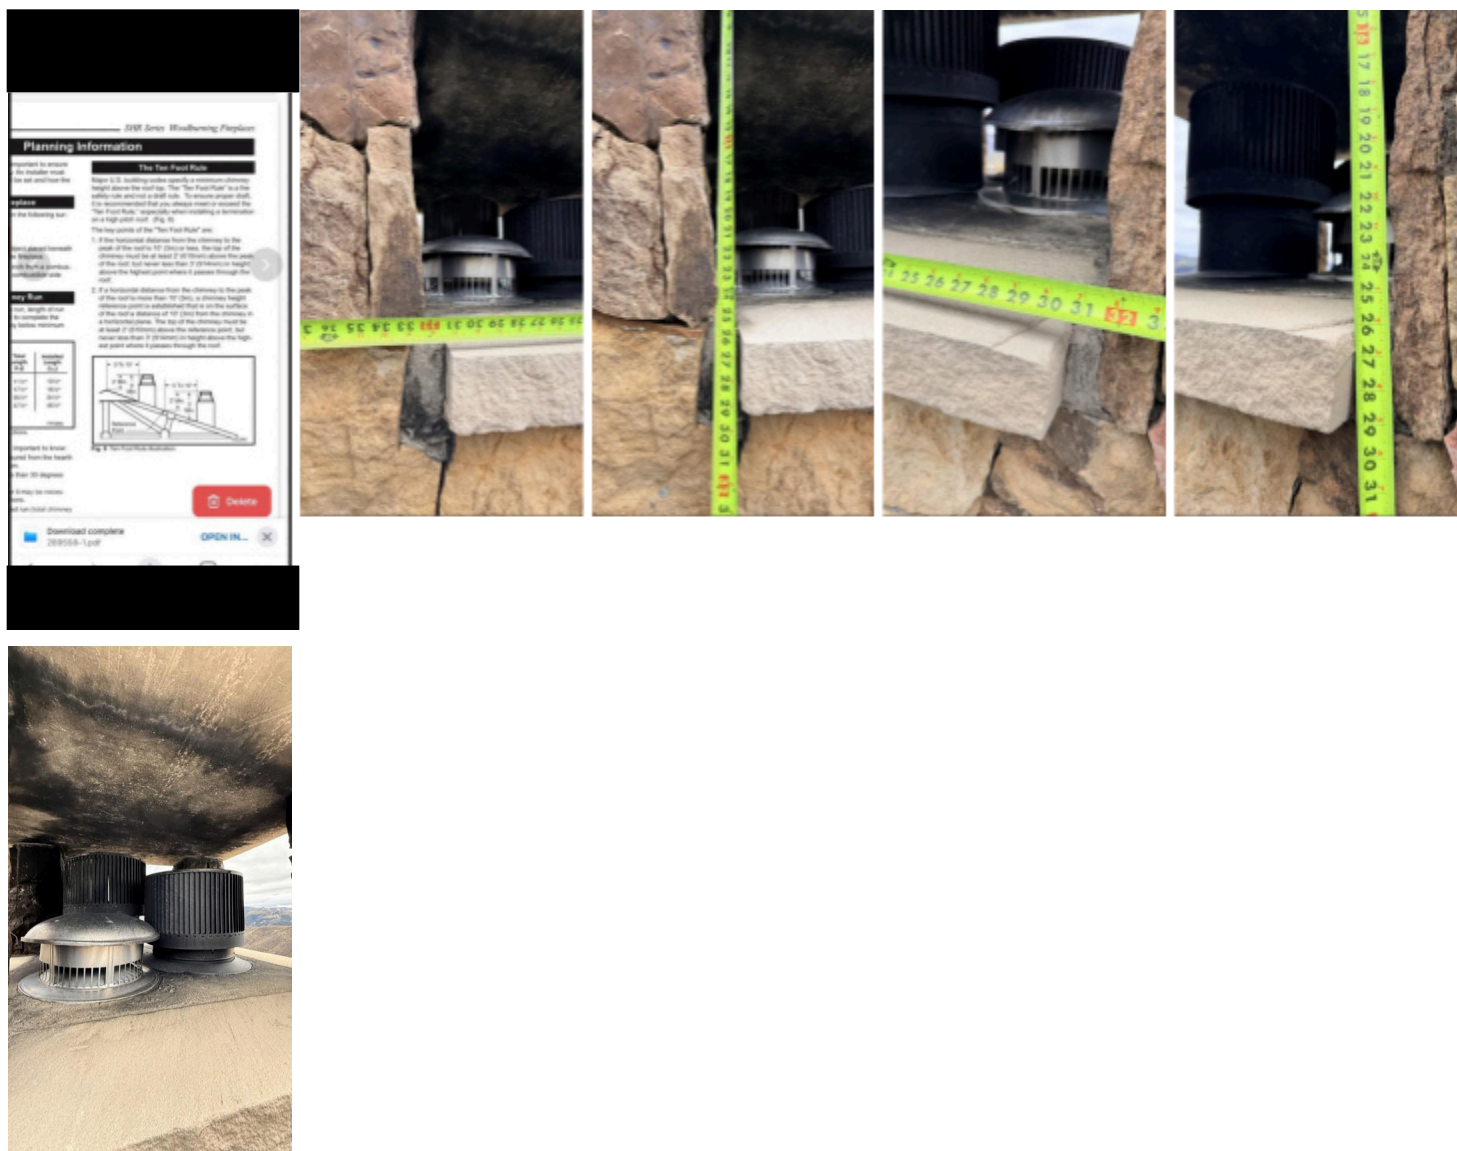
### 3.19. Main Level Great Room Fireplace – Shrouds – Deficiencies Noted

**Description/Notes:** The termination is located within a custom field-built stone enclosure/crown. The manufacturer provides specific listed chase-top terminations and also provides separately listed optional SKDSBL and PKDSBL decorative shrouds for the Type 11CF chimney system. Those listed shroud instructions require the shroud to be centered over the termination, require the prescribed multiple-termination spacing, and require a minimum 5-inch air space.

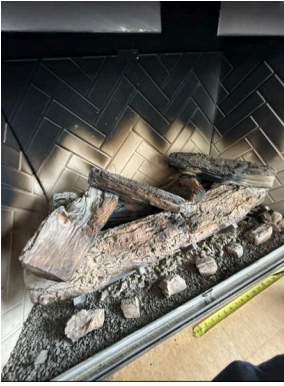
#### 4.4. Main Level Hearth Room – Arrival Test Fire – Deficiencies Noted

**Description/Notes:** Gas was off. Electrical is being worked on throughout the house.
