**SAMPLE REPORT**

**Inspection/Service Report**

Anonymized inspection example  
Client and property details withheld

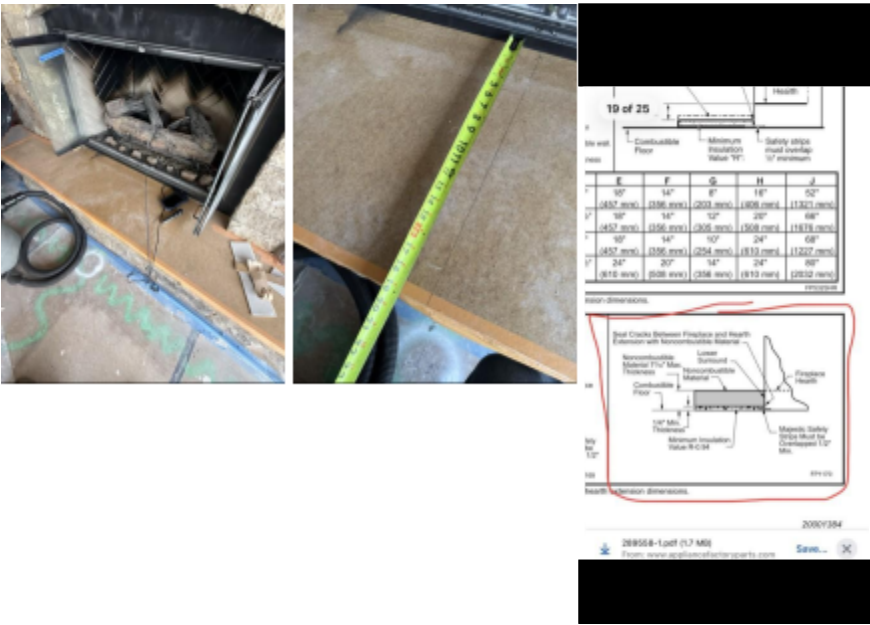
4.6. Main Level Hearth Room – Hearth Extension – Deficiencies Noted

**Description/Notes:** This fireplace is installed with a raised hearth extension constructed of noncombustible materials substantially flush with the fireplace hearth/opening. The hearth extension projects approximately 19 inches in front of the fireplace opening; the manufacturer's applicable requirement is 24 inches. The manufacturer's raised-hearth detail also requires a minimum insulation value of R-0.94 beneath the hearth extension. The concealed construction beneath the existing hearth extension could not be verified as providing the required thermal resistance.

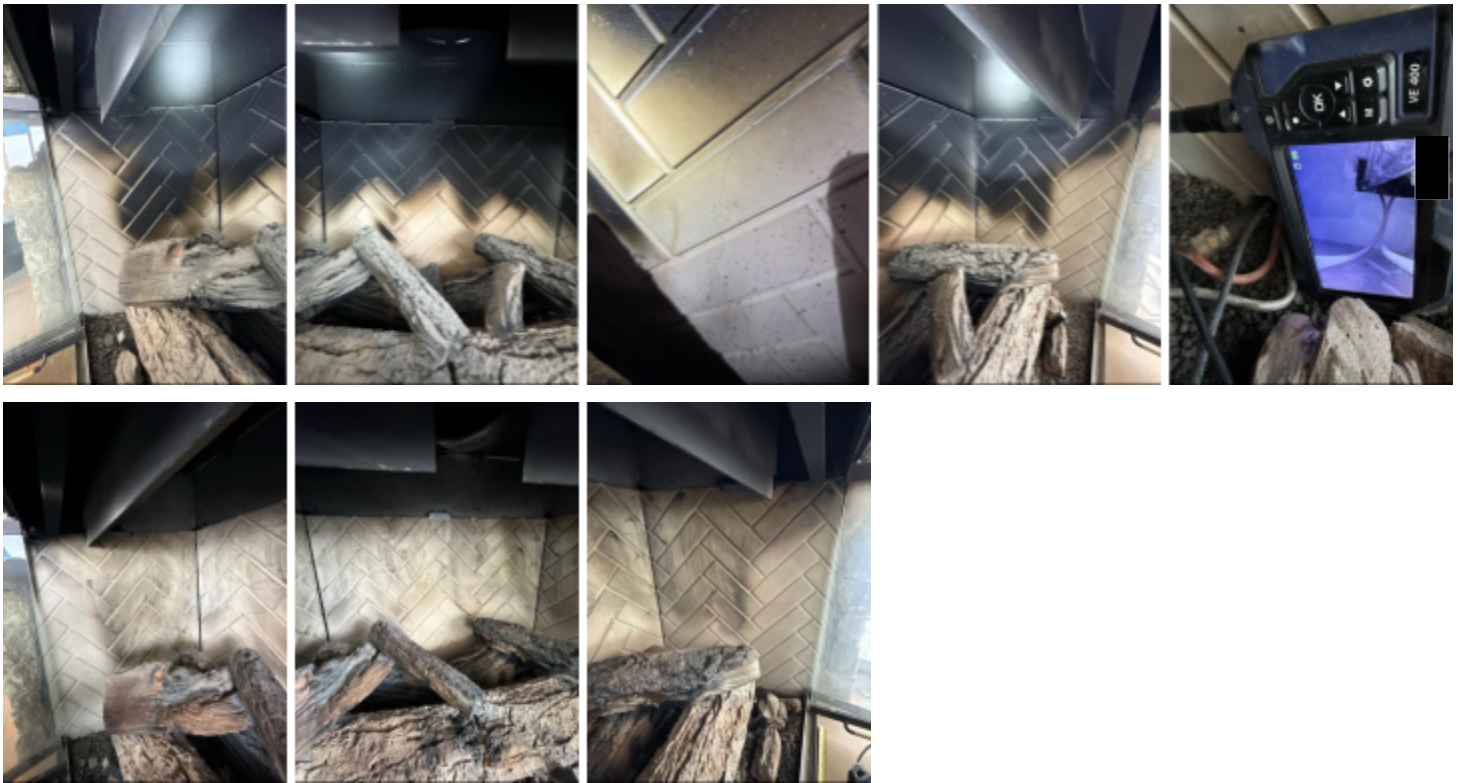
#### 4.9. Main Level Hearth Room – Firebox and Internal Components – Deficiencies Noted

**Description/Notes:** The gas-line penetration through the factory-built fireplace is not fully sealed in the manner prescribed by the fireplace manufacturer.

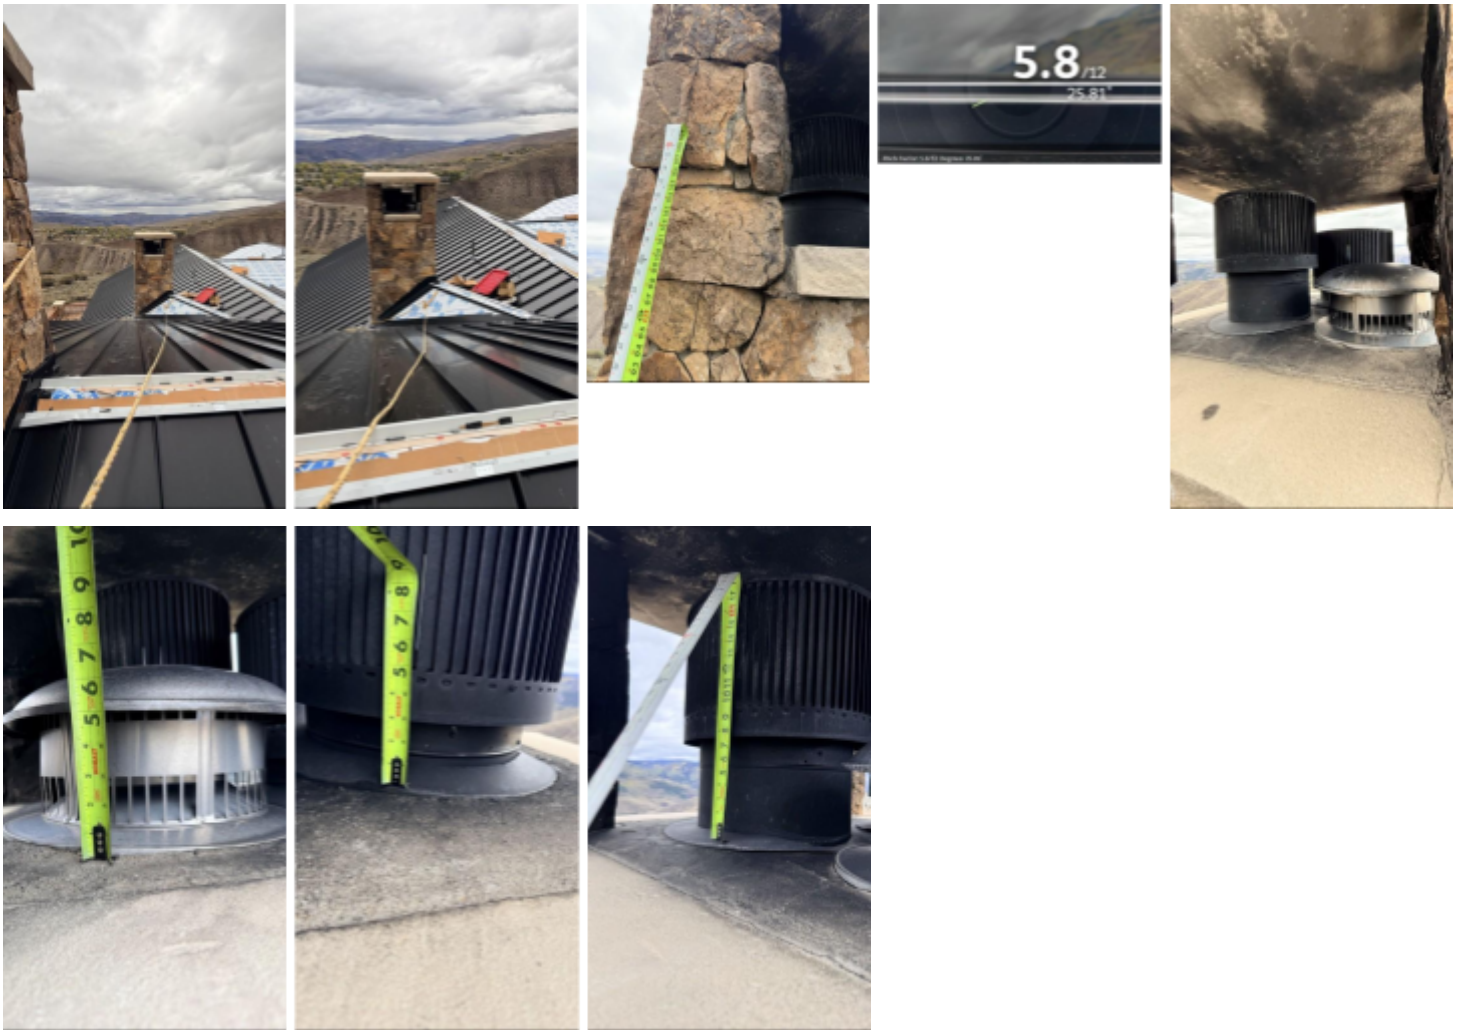
#### 4.20. Main Level Hearth Room – Factory-Built Chimney/Vent Termination – **Deficiencies Noted**

**Description/Notes:** The Type 11CF chimney satisfies the applicable overall minimum termination height above the roof and the manufacturer's Ten Foot Rule based on field measurements. This termination shares the same field-built stone chase/enclosure with other chimney/vent terminations. The manufacturer's termination instructions require chimney tops within one enclosure to be spaced a minimum of 21 inches on center. The observed spacing between the terminations is less than the required 21-inch minimum; an exact center-to-center dimension was not obtained during the inspection.

Because the SHR48 is a legacy appliance with limited proprietary parts availability, the practical ability to achieve an approved termination configuration within the existing shared stone chase should be considered together with the cost of the remaining repairs. If the required termination spacing and listed chase-top arrangement cannot reasonably be achieved, replacement with a currently supported appliance/chimney system should be considered. The fireplace/chimney was swept as necessary to facilitate inspection, and no reportable defect was identified in the accessible flue interior after cleaning. Reinspection is recommended before use.

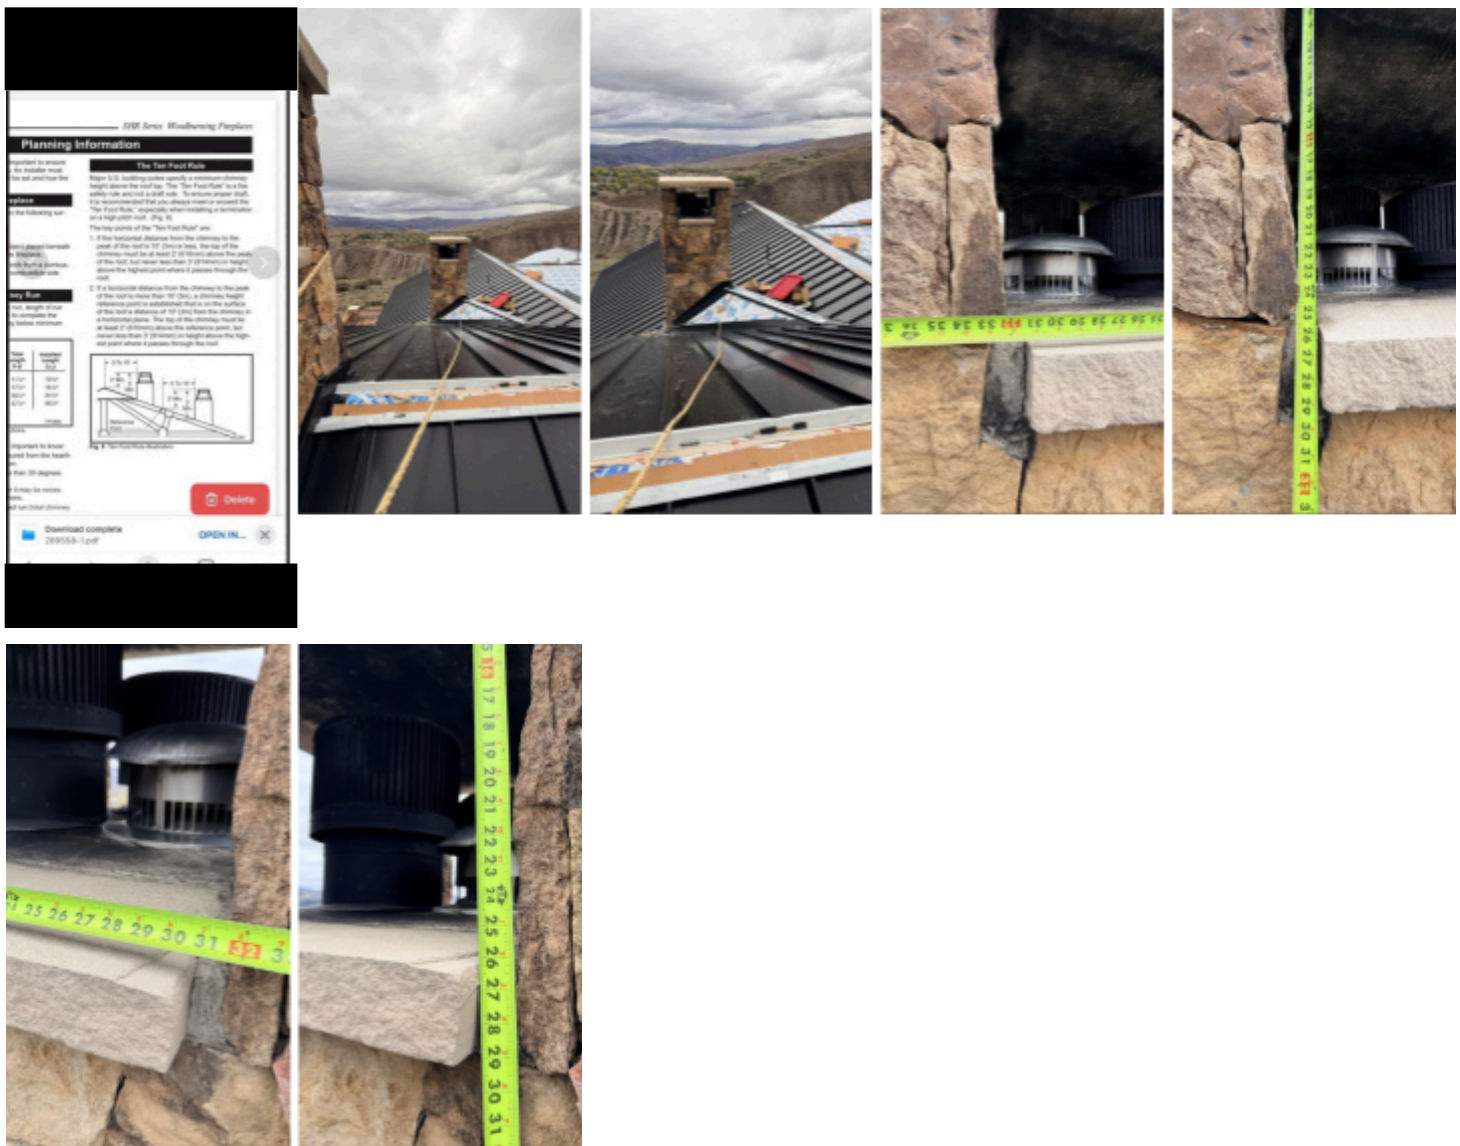
#### 4.21. Main Level Hearth Room – Shrouds – Deficiencies Noted

**Description/Notes:** The termination is located within the same custom field-built stone enclosure/crown. The SHR/Type 11CF manufacturer documentation provides specific listed chase-top terminations and separately listed SKDSBL and PKDSBL optional decorative shrouds. The listed shroud instructions require the prescribed chimney-top spacing and a minimum 5-inch air space.

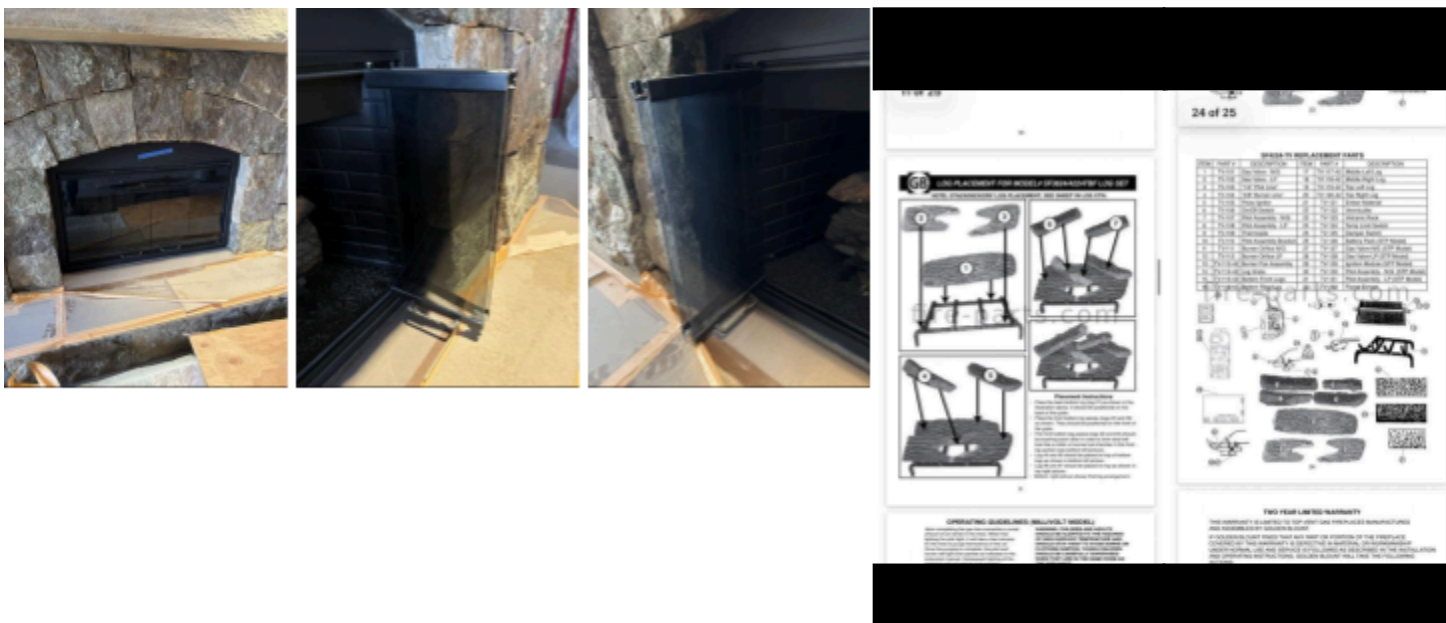
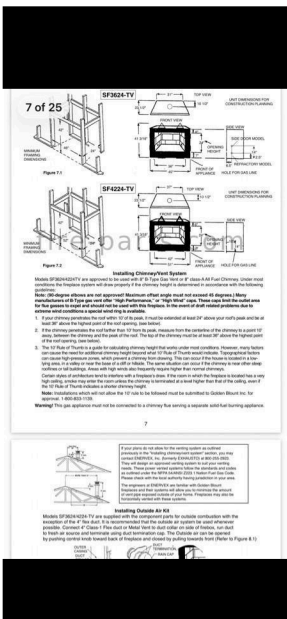
## 5.6. Lower Level Family Room – Screens and Glass Door Assemblies – Deficiencies Noted

**Description/Notes:** The installed aftermarket door assembly could not be identified as a manufacturer-approved component for the SF-4224-TV. The available manufacturer documentation reviewed does not identify this door assembly as an approved accessory. The fireplace can be operated with the existing doors in place and open, which may affect the airflow characteristics of the listed appliance.

Corrective work would include addressing the aftermarket door assembly, excessive facing projection, outside-air duct, vent clearances/fireblocking, damaged or irregular B-vent components, and the termination. No manufacturer

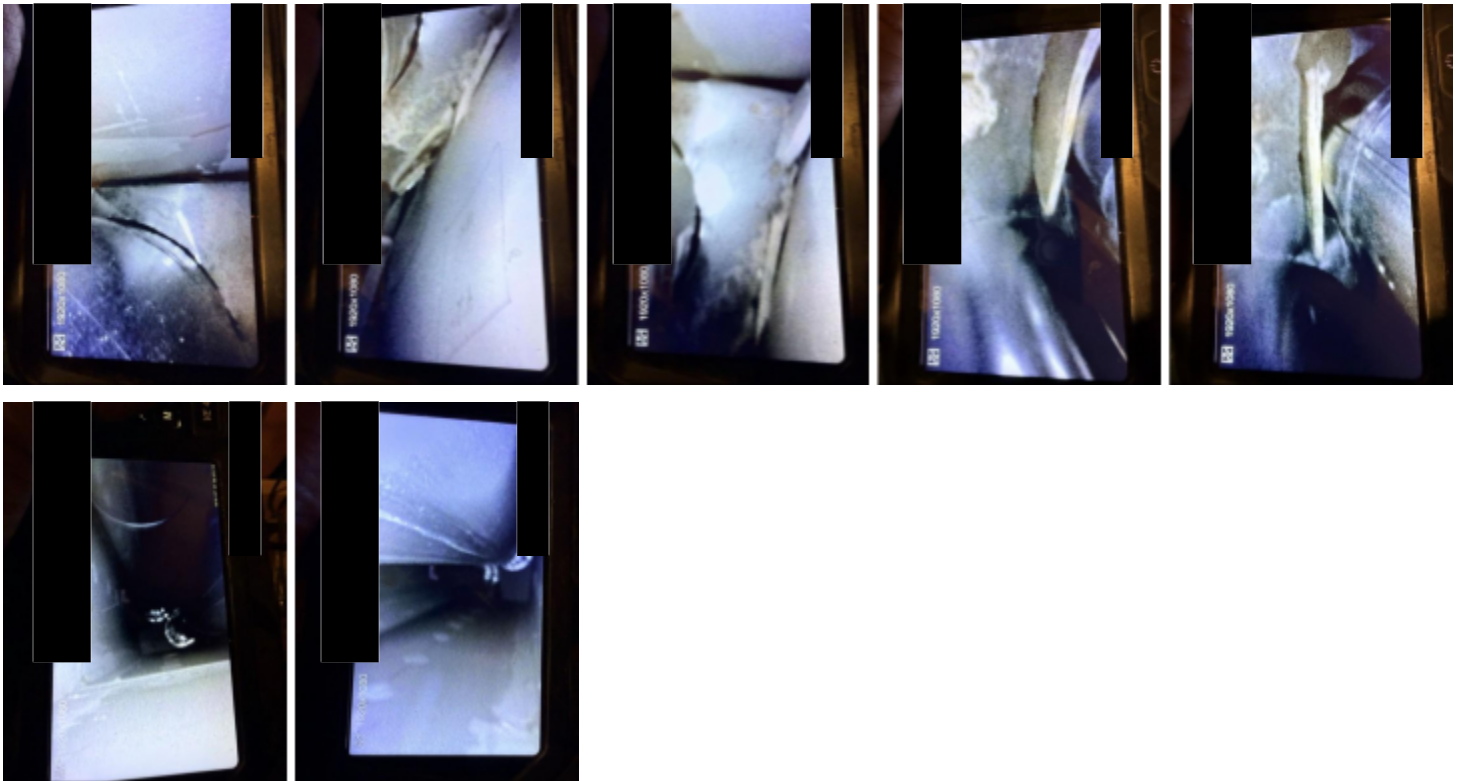
**Other Issue:** The firestop component itself is present. Clearance deficiencies involving combustible material/debris at this penetration are documented under Section 5.15 and are not duplicated as a separate firestop-component deficiency here.

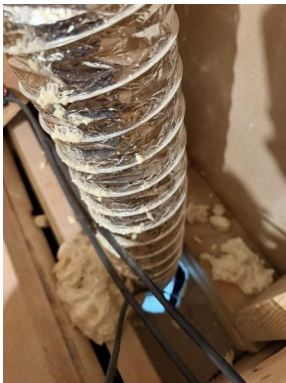
**Deficiencies noted:** Component/materials Missing.

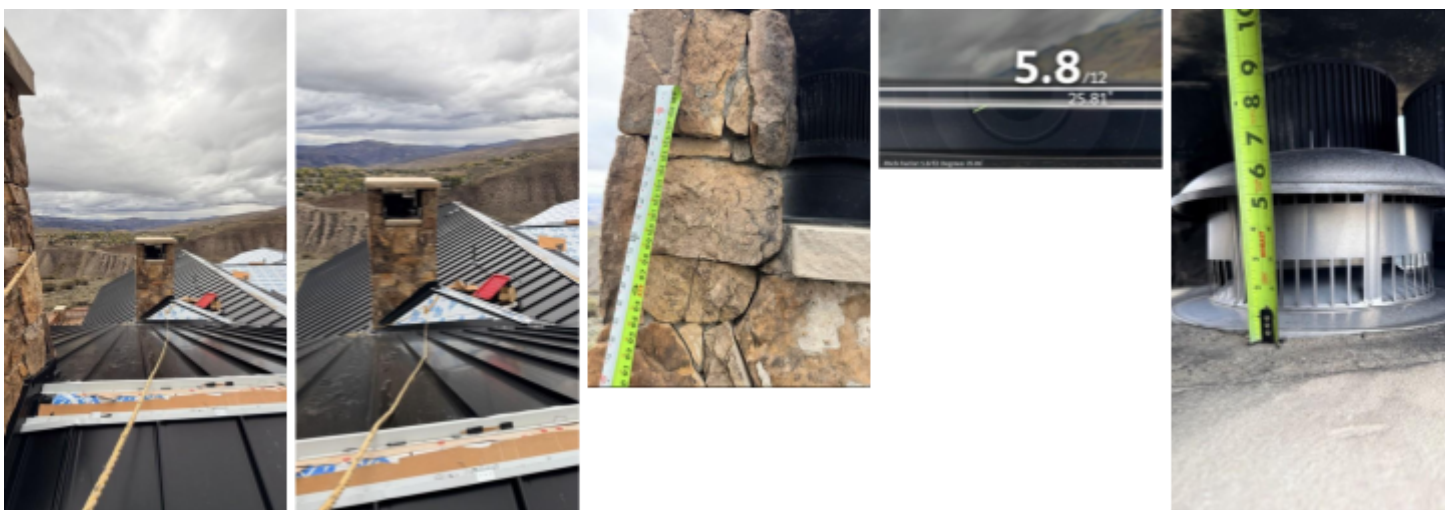
**Description/Notes:** The Golden Blount SF-4224-TV uses an 8-inch Type B gas vent. Golden Blount requires the chimney to meet its published minimum roof-height requirements and no manufacturer instruction was identified permitting those minimum requirements to be reduced because the termination is located within a chase, shroud, or architectural enclosure. The approved B-vent cap is recessed beneath/within the field-built stone crown rather than terminating in an unobstructed conventional configuration. The surrounding stone structure extends above the discharge area of the listed termination, and no documentation was identified establishing this recessed termination arrangement as approved.

Because the B-vent shares the enclosure with the two Type 11CF chimney terminations and the existing chase geometry already presents spacing and shroud-compatibility problems, replacement should also be evaluated as an alternative. A replacement appliance whose listed venting system provides a documented chase-top termination compatible with the intended architectural finish may offer a cleaner long-term solution. Appliance selection should therefore be coordinated with the proposed chase/termination design rather than treating the existing stone crown as a fixed reusable condition.

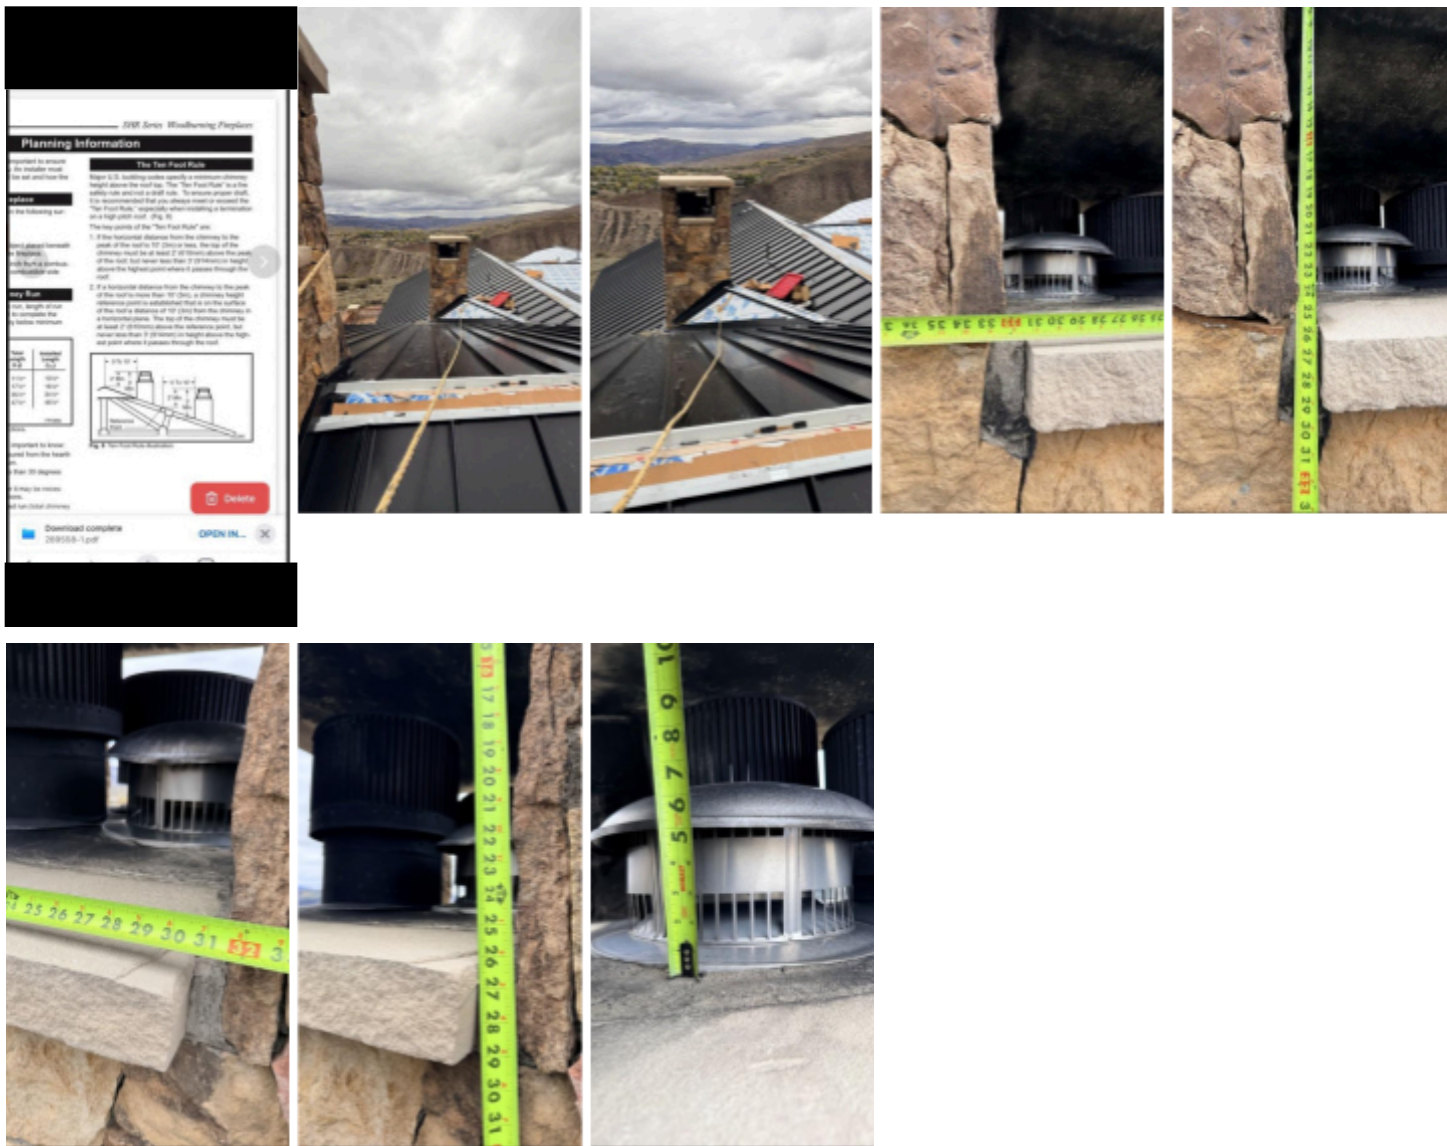
**Description/Notes:** The approved Type B gas-vent termination is located beneath and within a custom field-built stone enclosure/crown. Golden Blount's published installation instructions identify an 8-inch Type B gas vent or 8-inch Class-A chimney as approved venting methods but do not identify a listed decorative shroud or recessed stone termination configuration for this appliance. No documentation was identified approving the installed field-built enclosure.
