**SAMPLE REPORT**

**Inspection/Service Report**

Anonymized inspection example  
Client and property details withheld

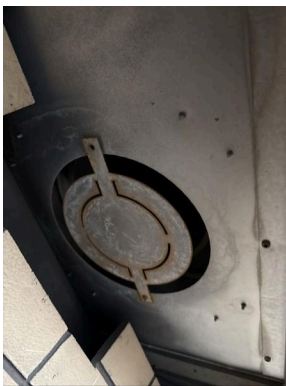
### 1.11. Primary Bedroom Fireplace – Dampers and Controls

**Description/Notes:** Air restrictor in place.

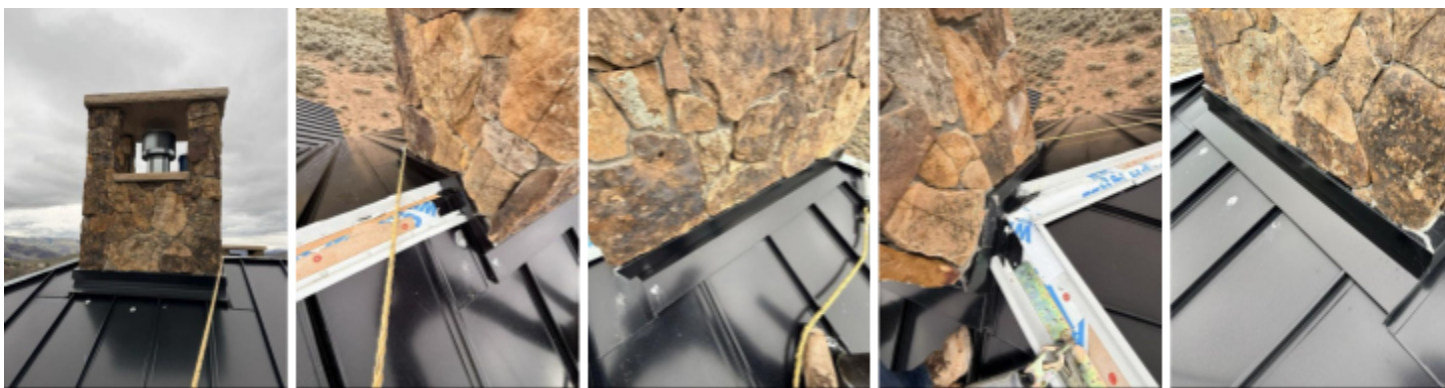
### 1.17. Primary Bedroom Fireplace – Flashings and Crickets

**Description/Notes:** Flashings are in the process of being completed.

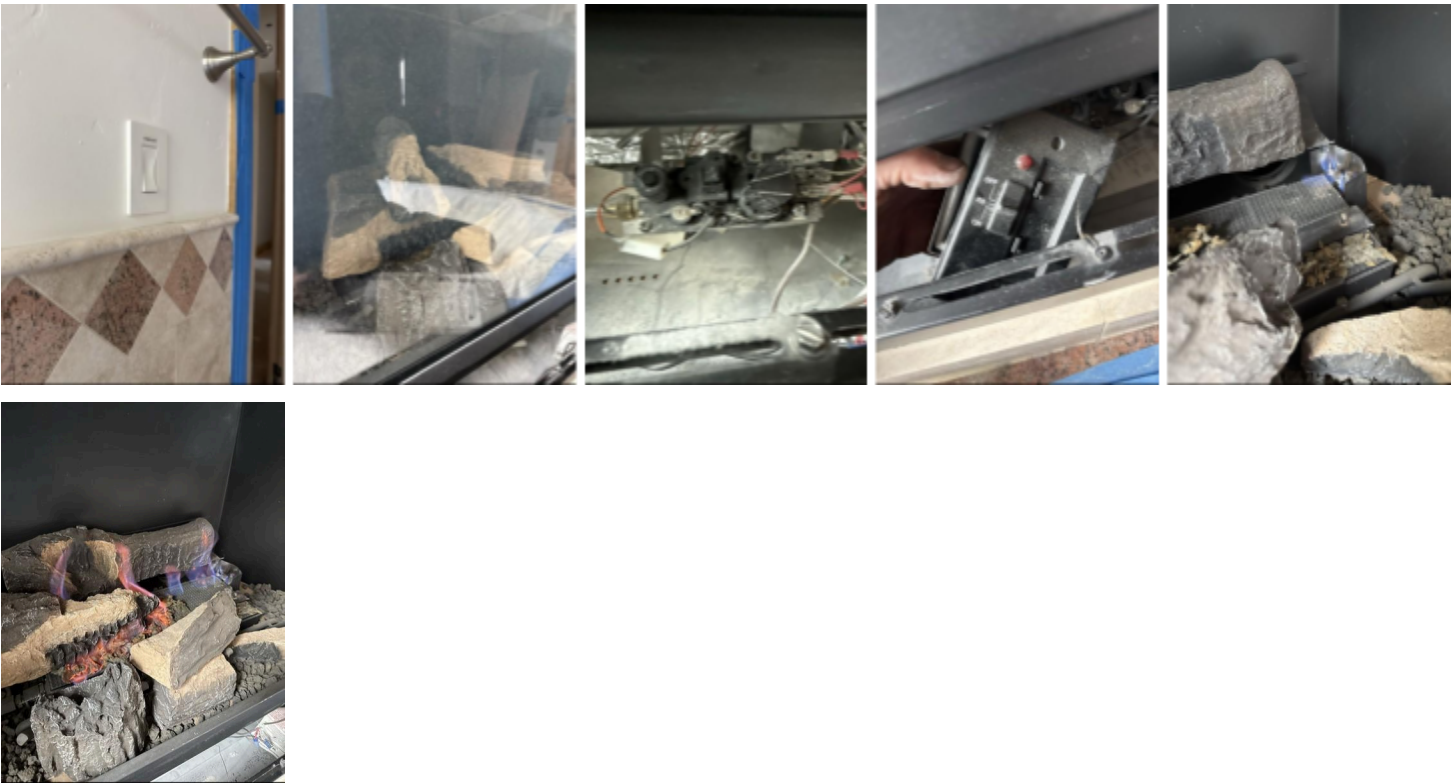
2.3. Primary Bathroom Fireplace – Arrival Test Fire

**Description/Notes:** After lighting, the pilot fireplace operated without issue. Pilot was extinguished and left the way it was found following test fire.

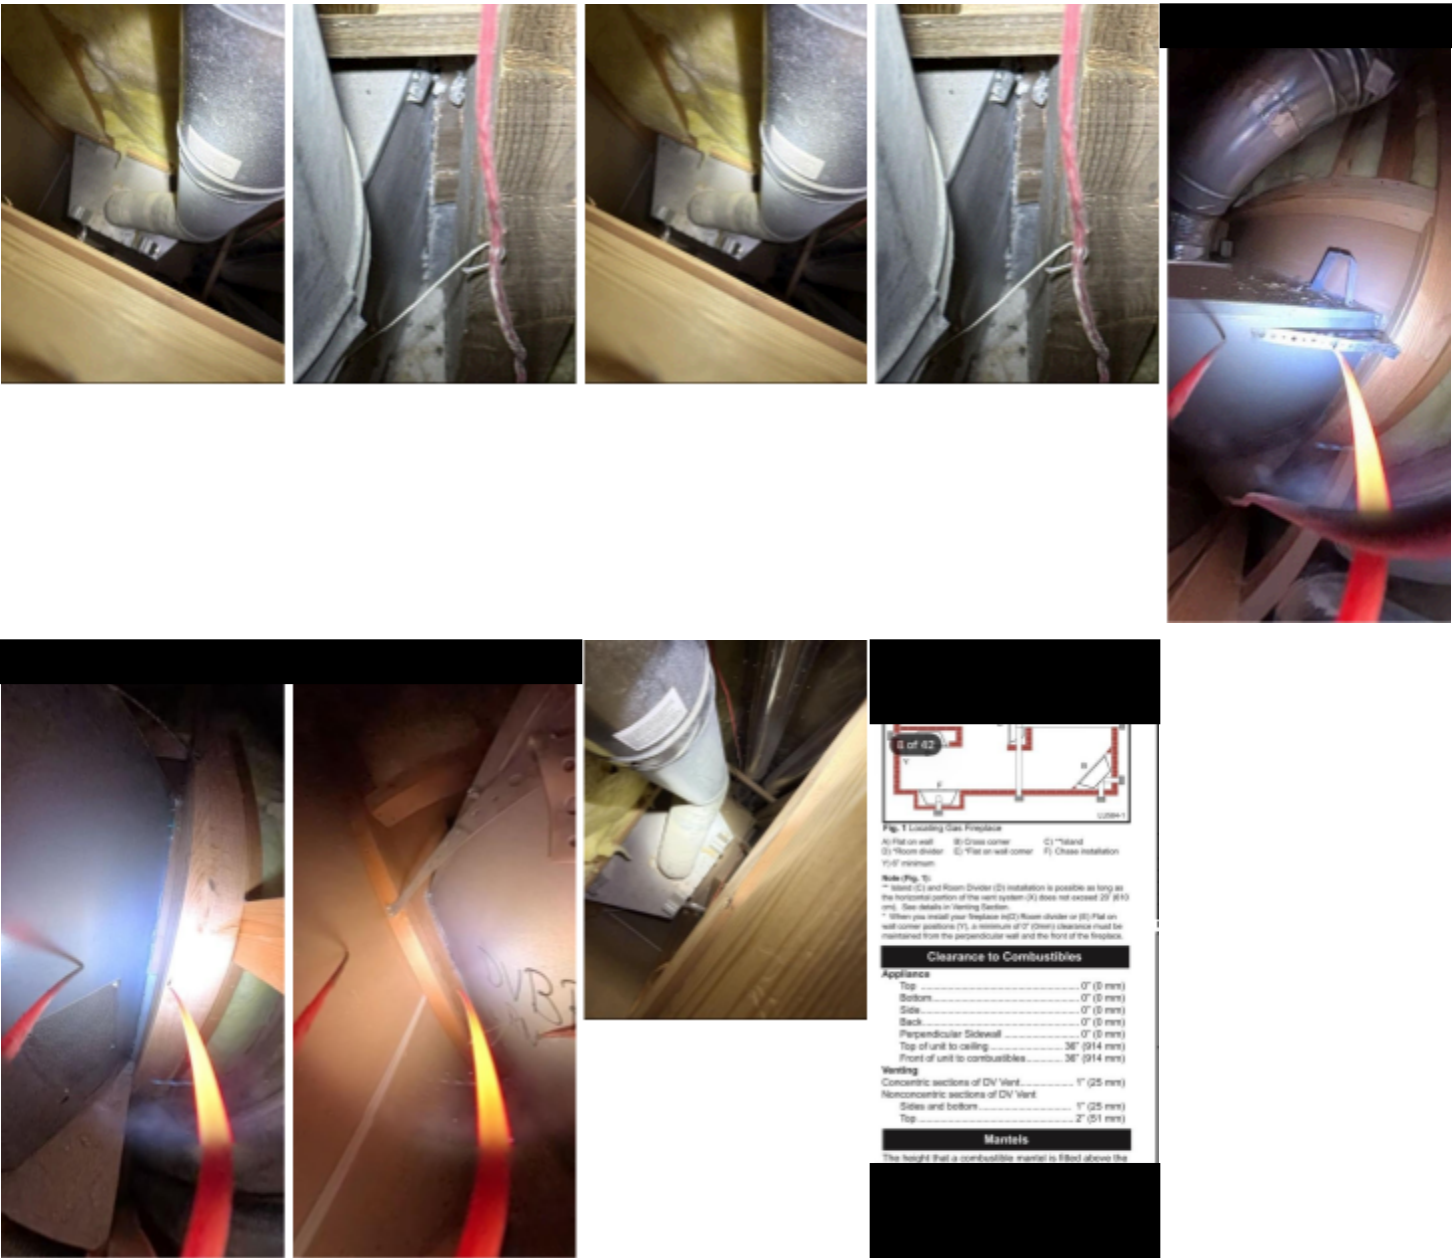
2.13. Primary Bathroom Fireplace – Factory-Built System Concealed in Construction

**Description/Notes:** Gypsum wallboard contacts the sides of the appliance cabinet. The DVBR36 installation instructions permit 0-inch clearance at the appliance sides and back; therefore, contact at these locations is not identified as a deficiency based solely on that condition. Vent clearances remain separate and are addressed elsewhere in this report.

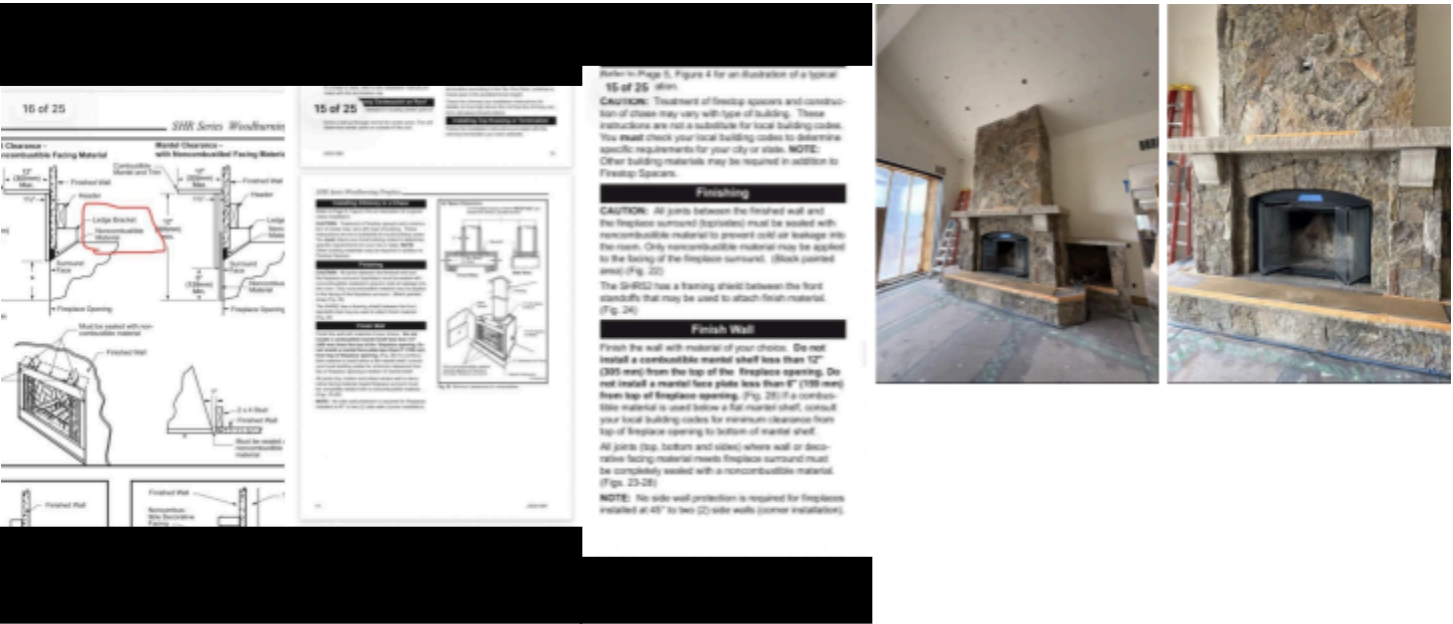
3.3. Main Level Great Room Fireplace – Surround Facing Materials and Fireplace Dimensions

Opening Geometry: Opening Width 55 in, Opening Height (to Shoulder for Arches) 36 in

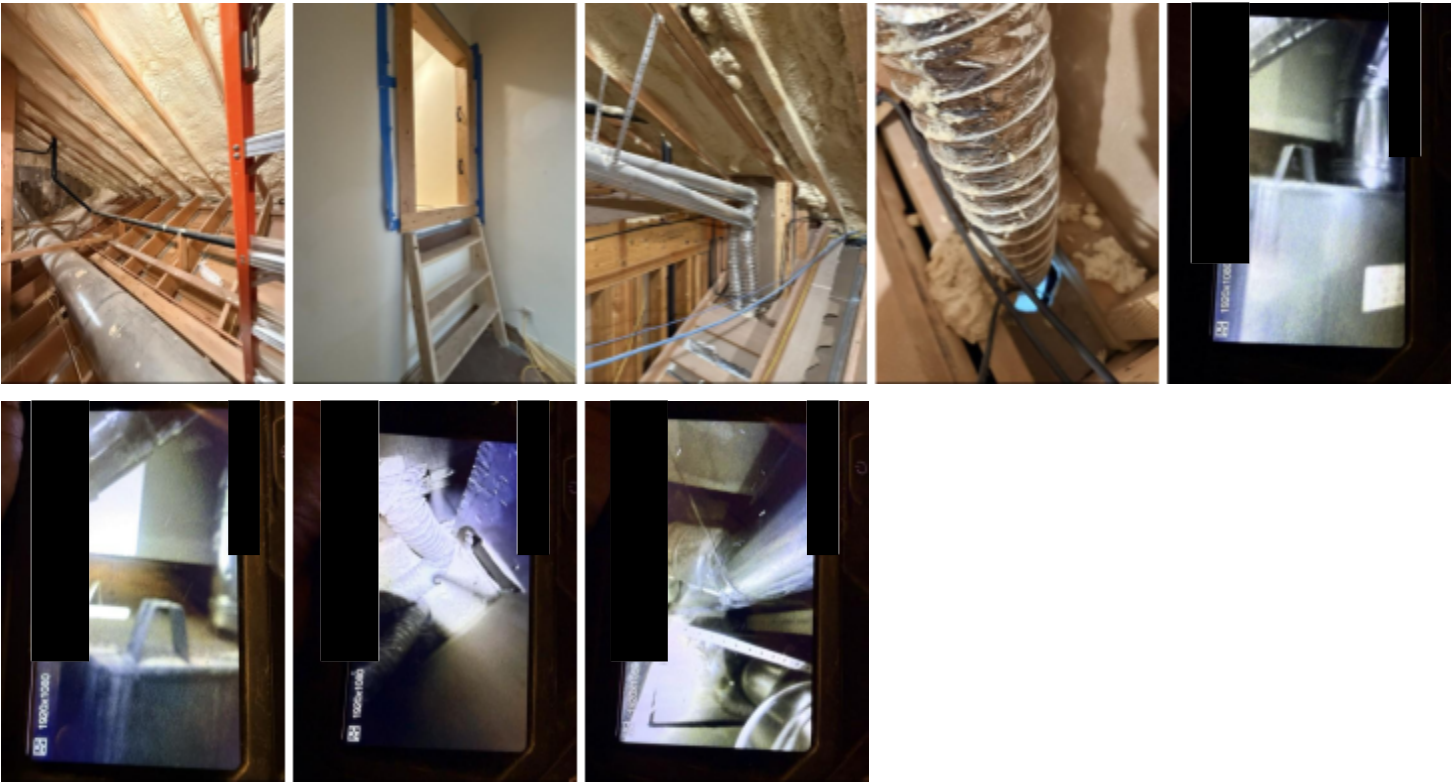
3.13. Main Level Great Room Fireplace – Factory-Built System Concealed in Construction

**Description/Notes:** OSB was observed above the fireplace at the face. Review of the manufacturer instructions indicates combustible sheathing is permitted at this location; therefore, no deficiency is assigned based upon this condition.

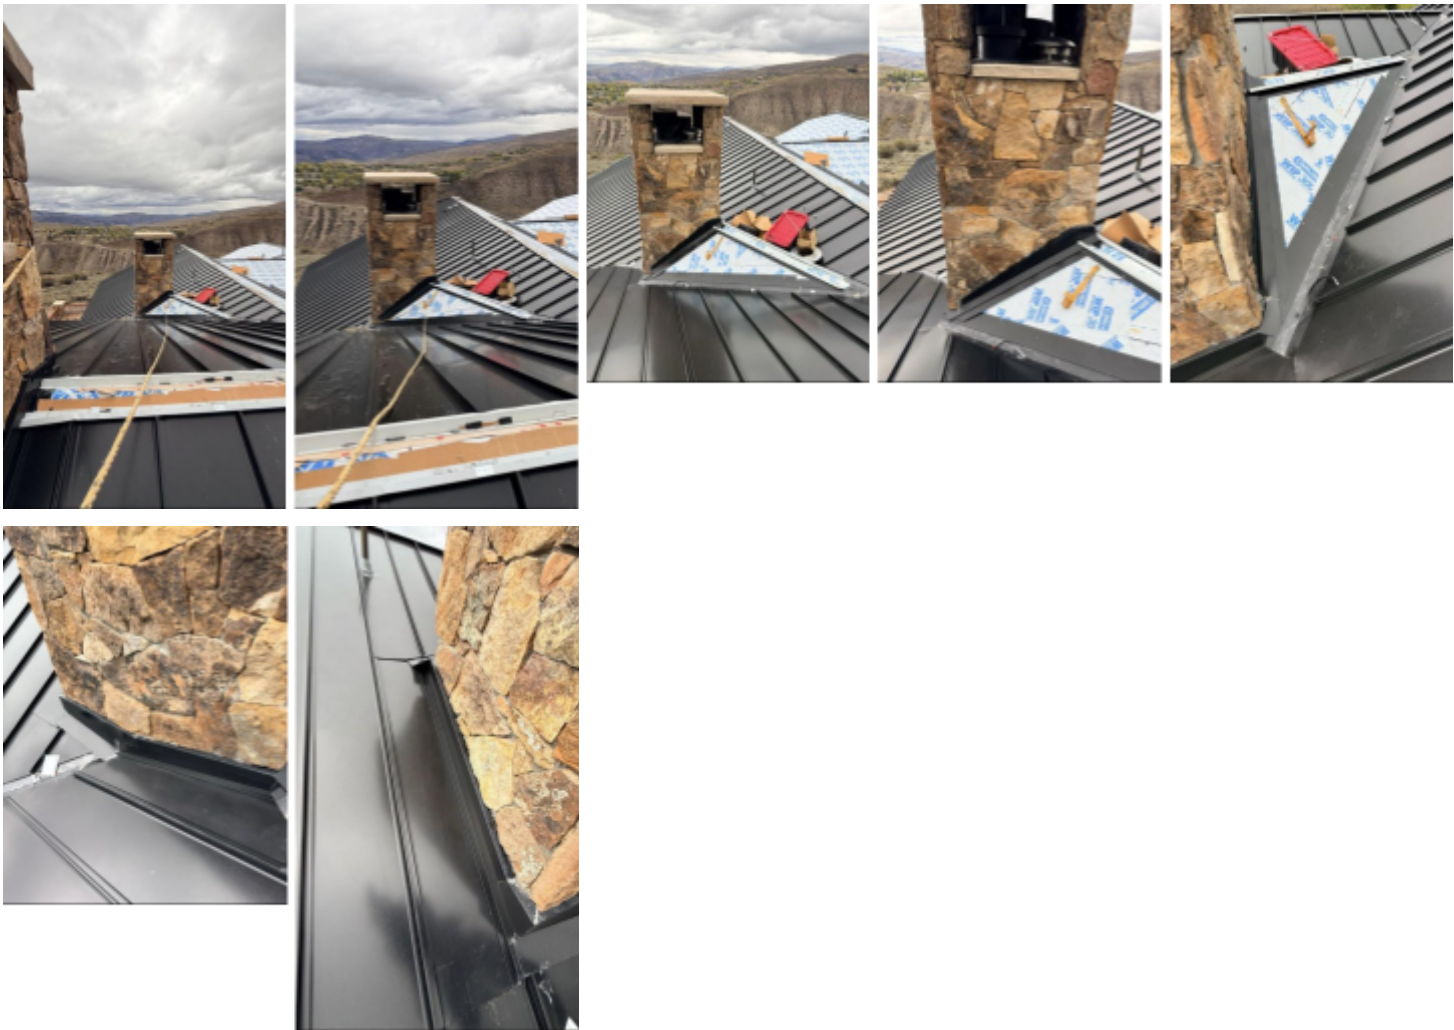
3.17. Main Level Great Room Fireplace – Flashings and Crickets

**Description/Notes:** Flashing is being completed now

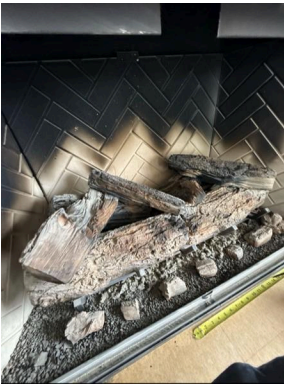
4.2. Main Level Hearth Room – Listing Information - Inserted Appliance – Deficiencies Noted

**Deficiencies noted:** Insert data plate missing, illegible, or inaccessible.

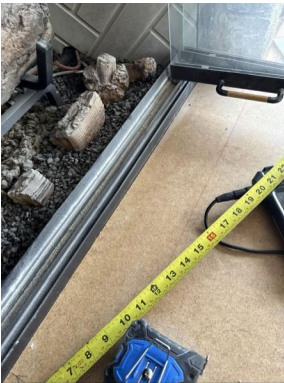
4.7. Main Level Hearth Room – Spark/Z-Strip

**Access limitations noted:** Not Accessible.

**Description/Notes:** The manufacturer's instructions require the applicable hearth/safety-strip detail as part of the listed installation. Verification should be made when the hearth assembly is opened for corrective work. No representation is made from this inspection that the concealed component is either present or absent.

**Other Issue:** The required hearth safety-strip detail is concealed by the existing hearth construction and could not be directly observed. Its presence and installation cannot be confirmed from the accessible areas.

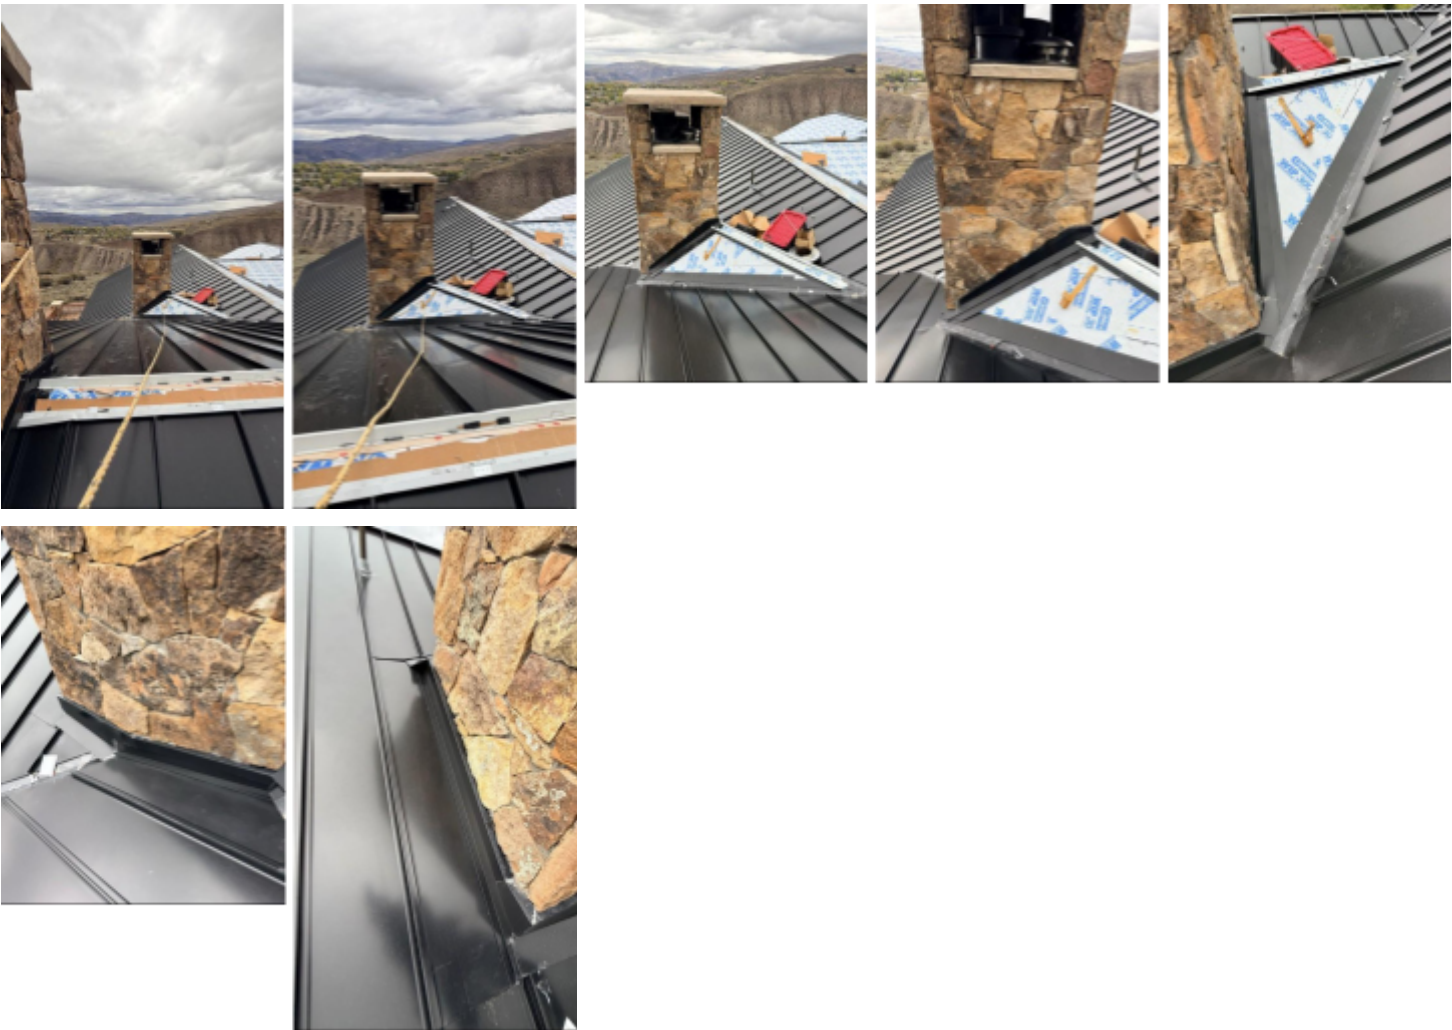
4.19. Main Level Hearth Room – Flashings and Crickets

**Description/Notes:** Flashing being completed.

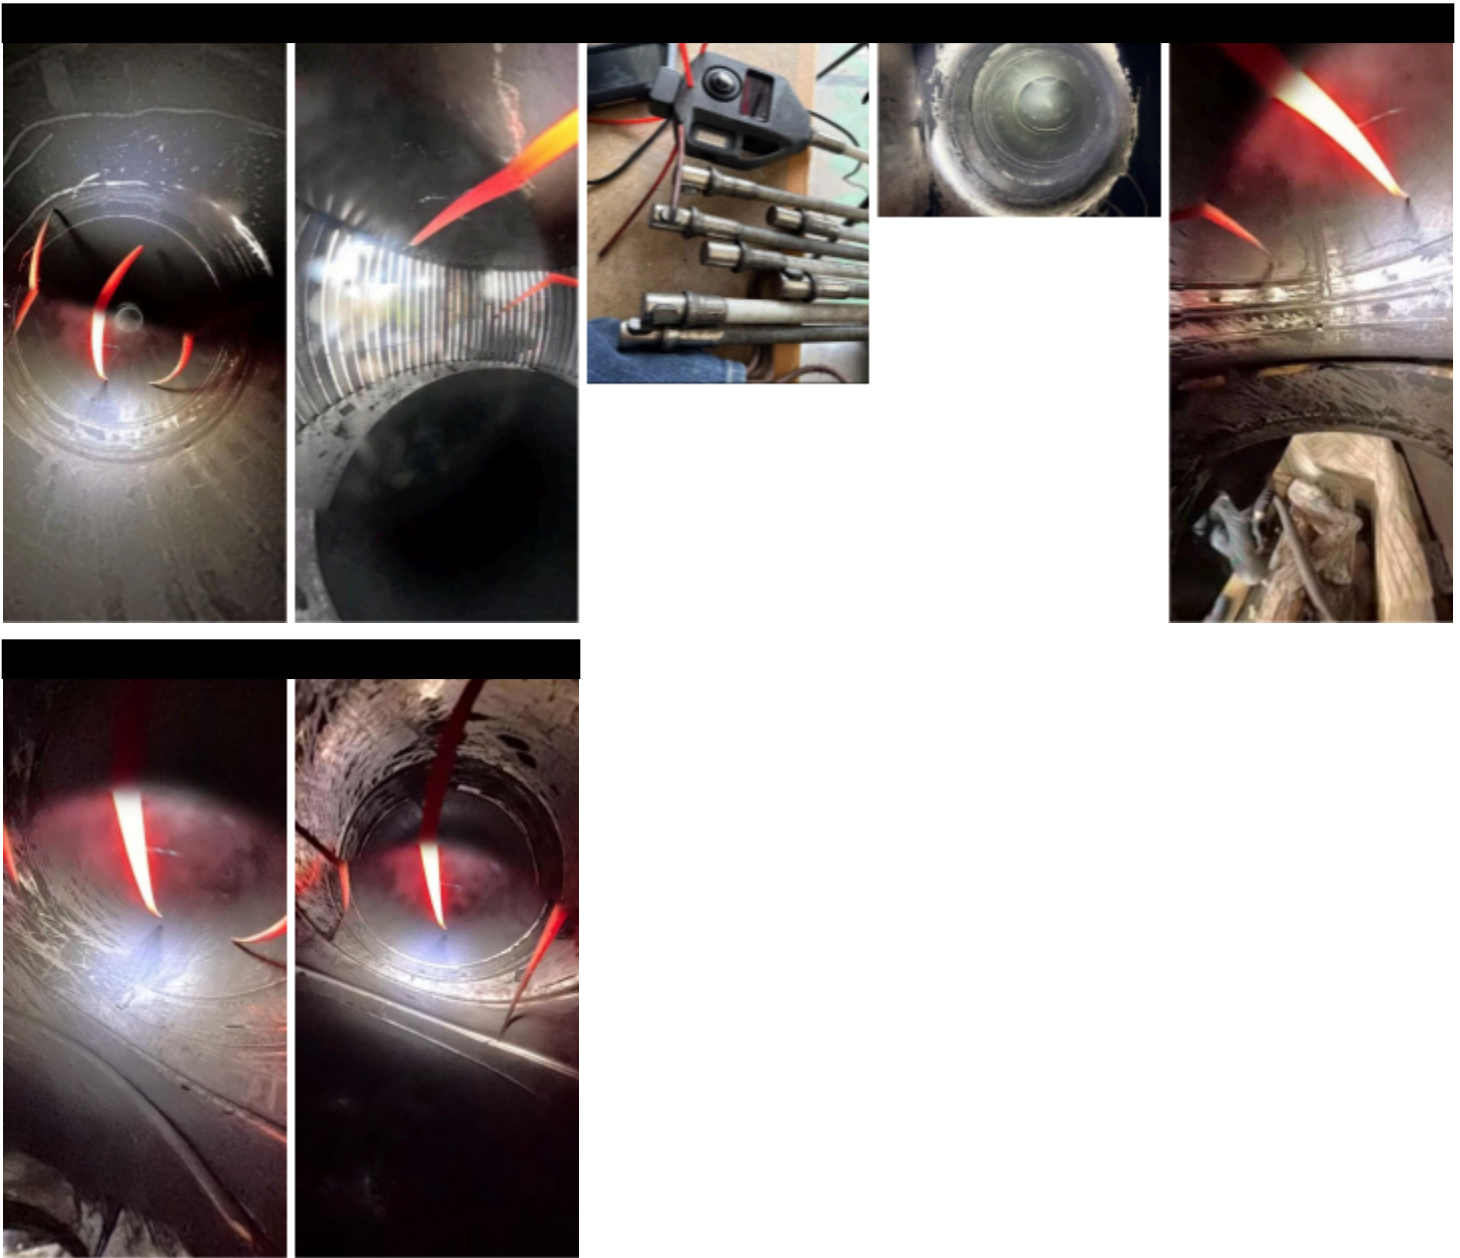
#### 4.22. Main Level Hearth Room – Factory Built Flue Interior – **Nothing to Report**

**Description/Notes:** This was the only fireplace/chimney swept during this inspection. Sweeping was performed as necessary to remove deposits and permit adequate internal evaluation. Following cleaning, internal camera inspection did not identify a reportable defect within the accessible factory-built flue interior. The other four systems did not require sweeping to complete their inspections and were not swept.

**Chimney / Flue Sizing:** Measured At Factory-Built Flue Interior, Flue Shape Round, Actual Installed Diameter 8 in, Flue Height 28 ft, Actual Flue Area (calculated) 50.265482 sq in, Manufacturer/Listing Required Diameter 8 in, Sizing Assessment MET, Sizing Evaluation Installed size matches the listed size or has documented listing sizing approval. Component/brand compatibility requires its separate inspection., Calculation Rules measurement-domains.v3, Chimney / Flue Sizing Compliance: **MET**

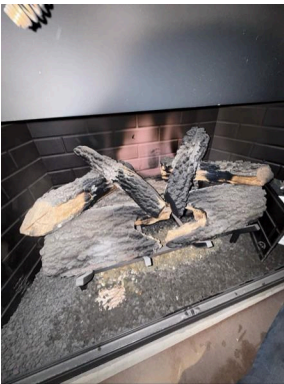
5.3. Lower Level Family Room – Arrival Test Fire – Deficiencies Noted

**Description/Notes:** Unit cannot be tested as there was no gas. The key valve was turned on, but it did not allow gas to flow to the valve and pilot assembly. I turned the key valve back off before leaving.

**Deficiencies noted:** Did not test fire.

**Explanation:** Operational testing could not be completed because gas was not available at the appliance. The key-operated shutoff was opened during the attempted test, but gas did not reach the appliance valve/pilot assembly; the key valve was returned to the off position before departure. Accordingly, no conclusion is made regarding ignition, burner operation, draft, control response, or other operating characteristics. The gas-supply condition should be evaluated and the appliance operationally tested after the other documented deficiencies have been corrected.

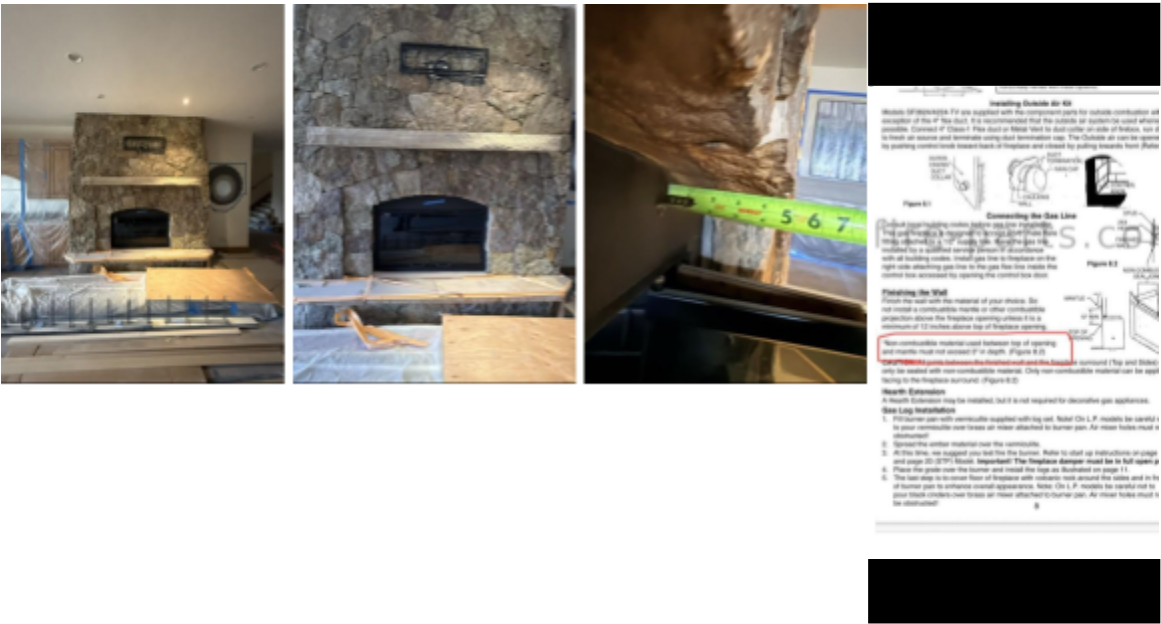
5.4. Lower Level Family Room – Surround Facing Materials and Fireplace Dimensions – Deficiencies Noted

**Deficiencies noted:** Other Issue.

**Other Issue:** Facing materials exceed the 3 inch maximum for non-combustible material.

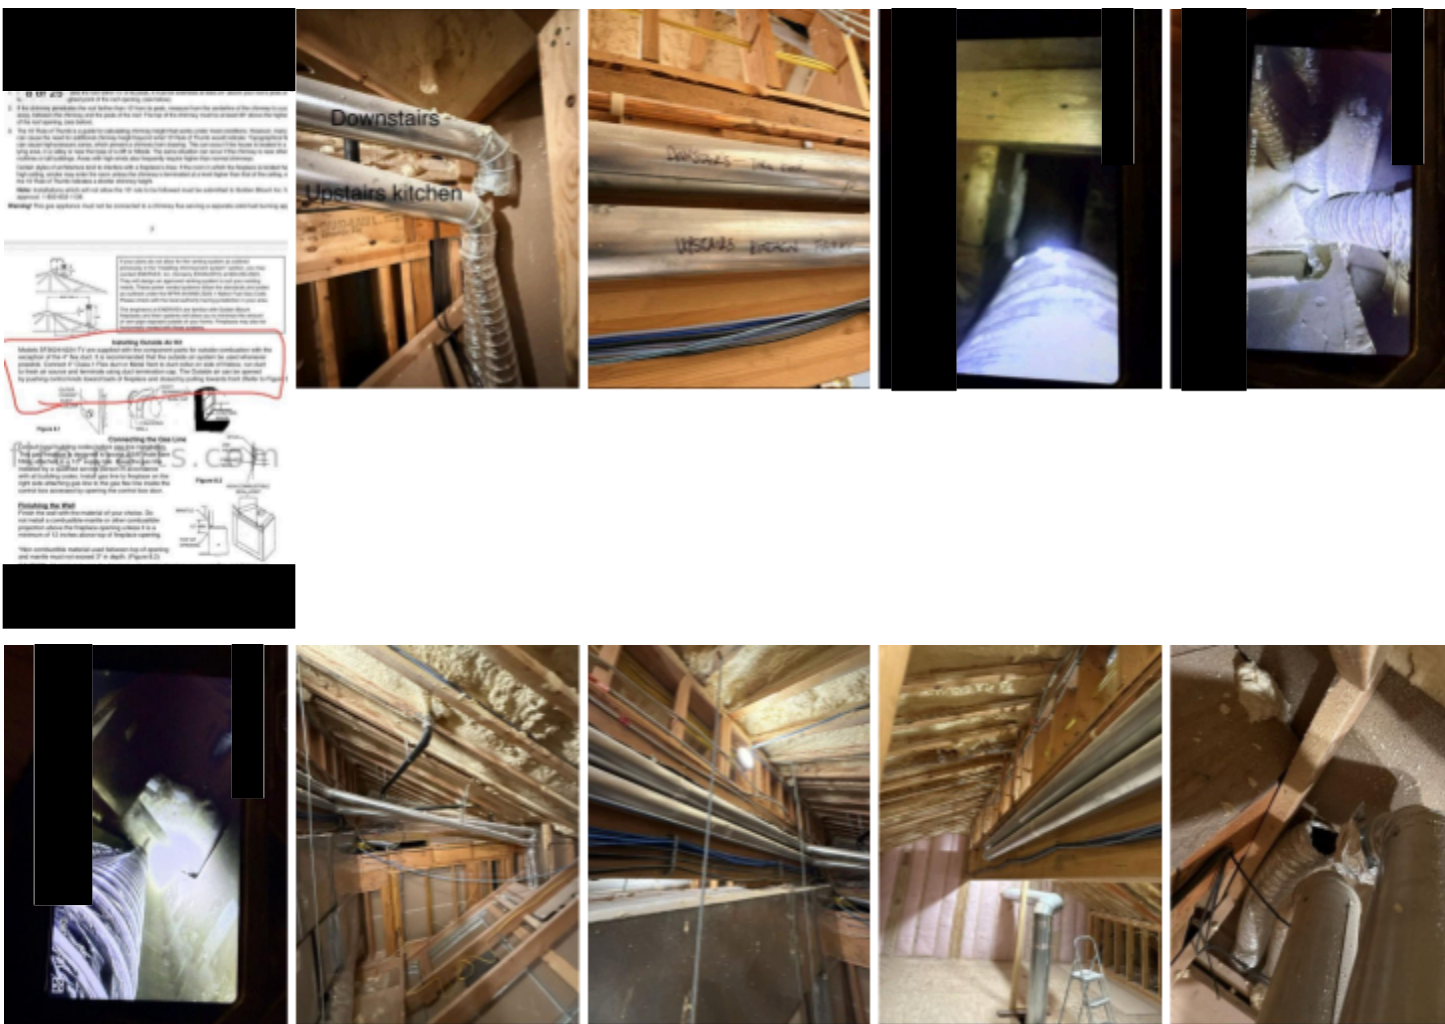
## 5.8. Lower Level Family Room – Combustion Air System – **Deficiencies Noted**

An outside-combustion-air system is installed but is disconnected/open within the attic. The current Golden Blount instructions describe use of outside air as recommended whenever possible and require an installed outside-air duct to run to a fresh-air source and terminate with the specified termination cap. Because an outside-air system has been installed here, it should either be restored to a complete approved exterior configuration or otherwise properly resolved so that it does not terminate unintentionally within the attic.

**Deficiencies noted:** Improper Termination/inlet Location, Damaged/disconnected.

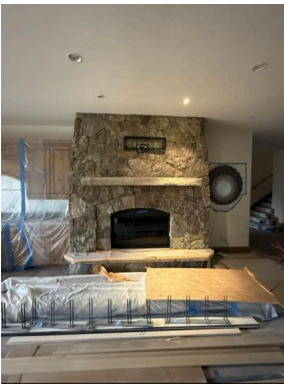
#### 5.14. Lower Level Family Room – Factory-Built System Concealed in Construction – **Inspection Limitation**

**Description/Notes:** I could not access into the lower chase given the access present.

**Access limitations noted:** Not Accessible.

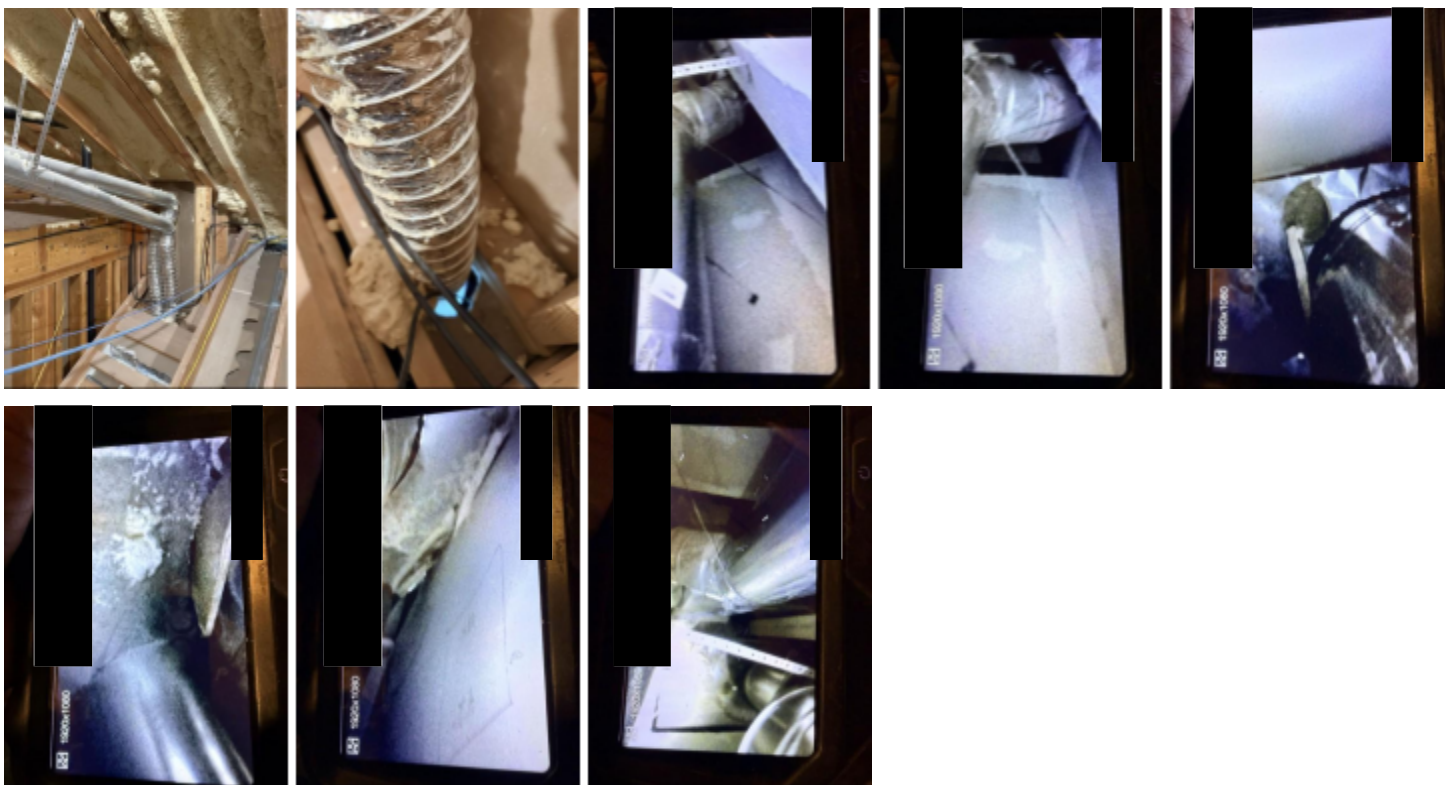
### 5.15. Lower Level Family Room – Factory-Built Chimney/Vent in Adjoining Areas – **Deficiencies Noted**

At the firestop penetration at the roof penetration combustible debris has fallen and wedged itself in between the fire stop around the pipe. Otherwise this pipe shares a Chase with the two fireplaces above it. It comes up to the right of the main level living room Fireplace and then elbows over to go up with the other two Chimneys.

**Deficiencies noted:** Clearances Not Met.

**Explanation:** Deficiencies related to a factory-built chimney/vent in adjoining areas were noted as outlined above. Factory-built chimneys and vents require specific clearances to prevent heat buildup, which can degrade or ignite nearby materials. Improper installation, excessive offsets, damaged or improperly installed components can compromise safety and performance. Clearances must meet manufacturer requirements to maintain system integrity and prevent fire hazards. Failure to comply may void the chimney/vent listing and create risks that could impact both safety and long-term reliability.

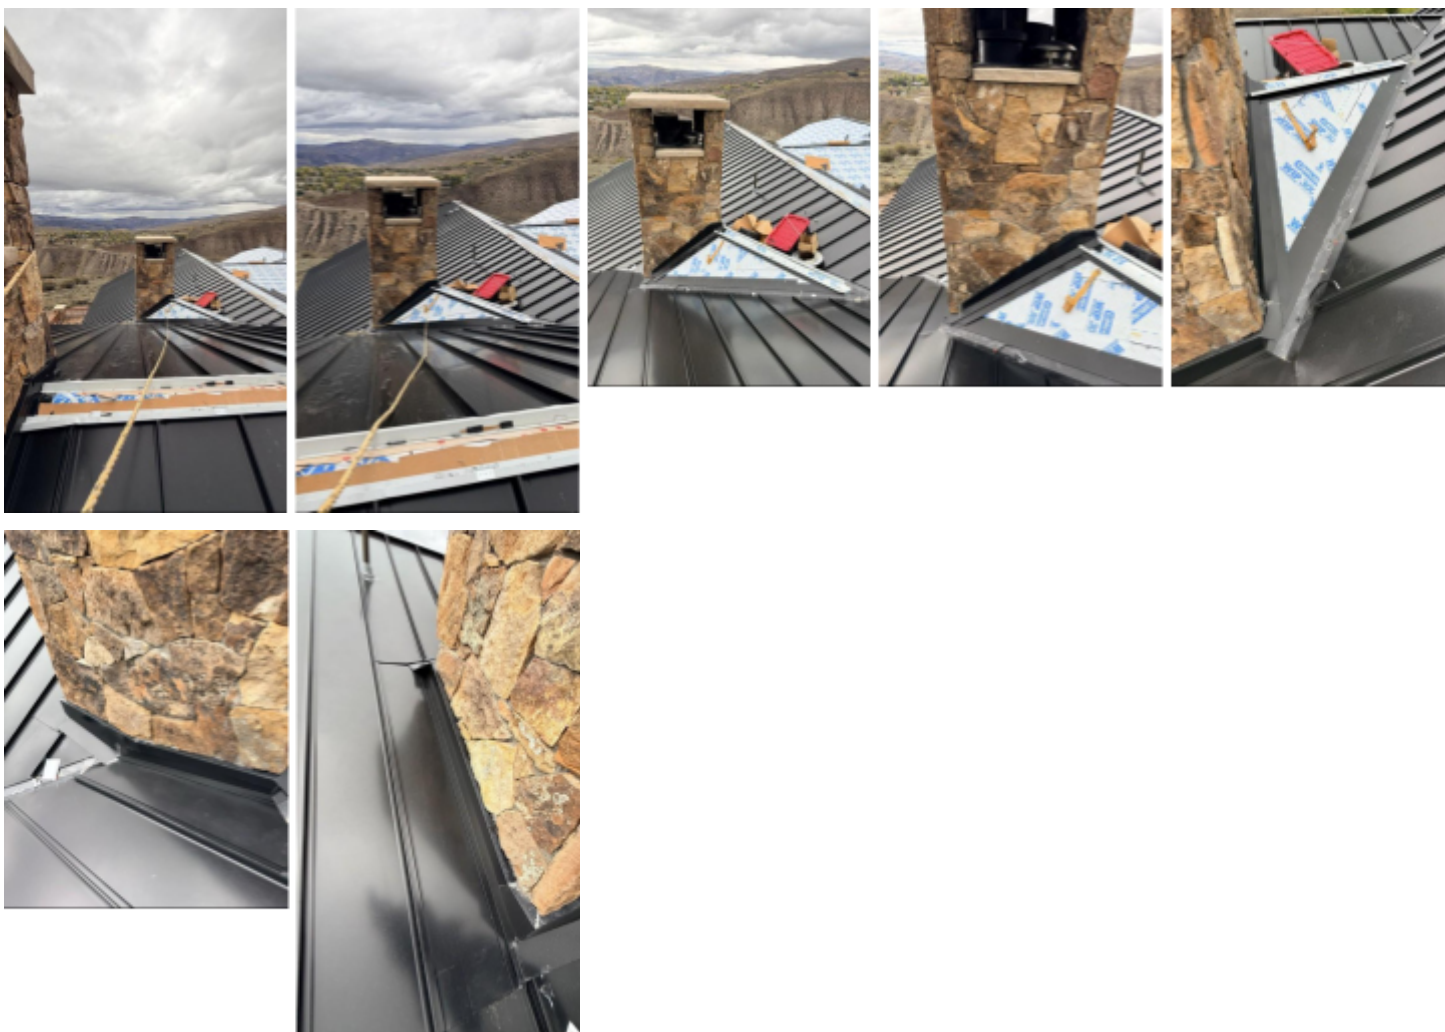
## 5.18. Lower Level Family Room – Flashings and Crickets – **Nothing to Report**

**Description/Notes:** Flashings are being installed now.

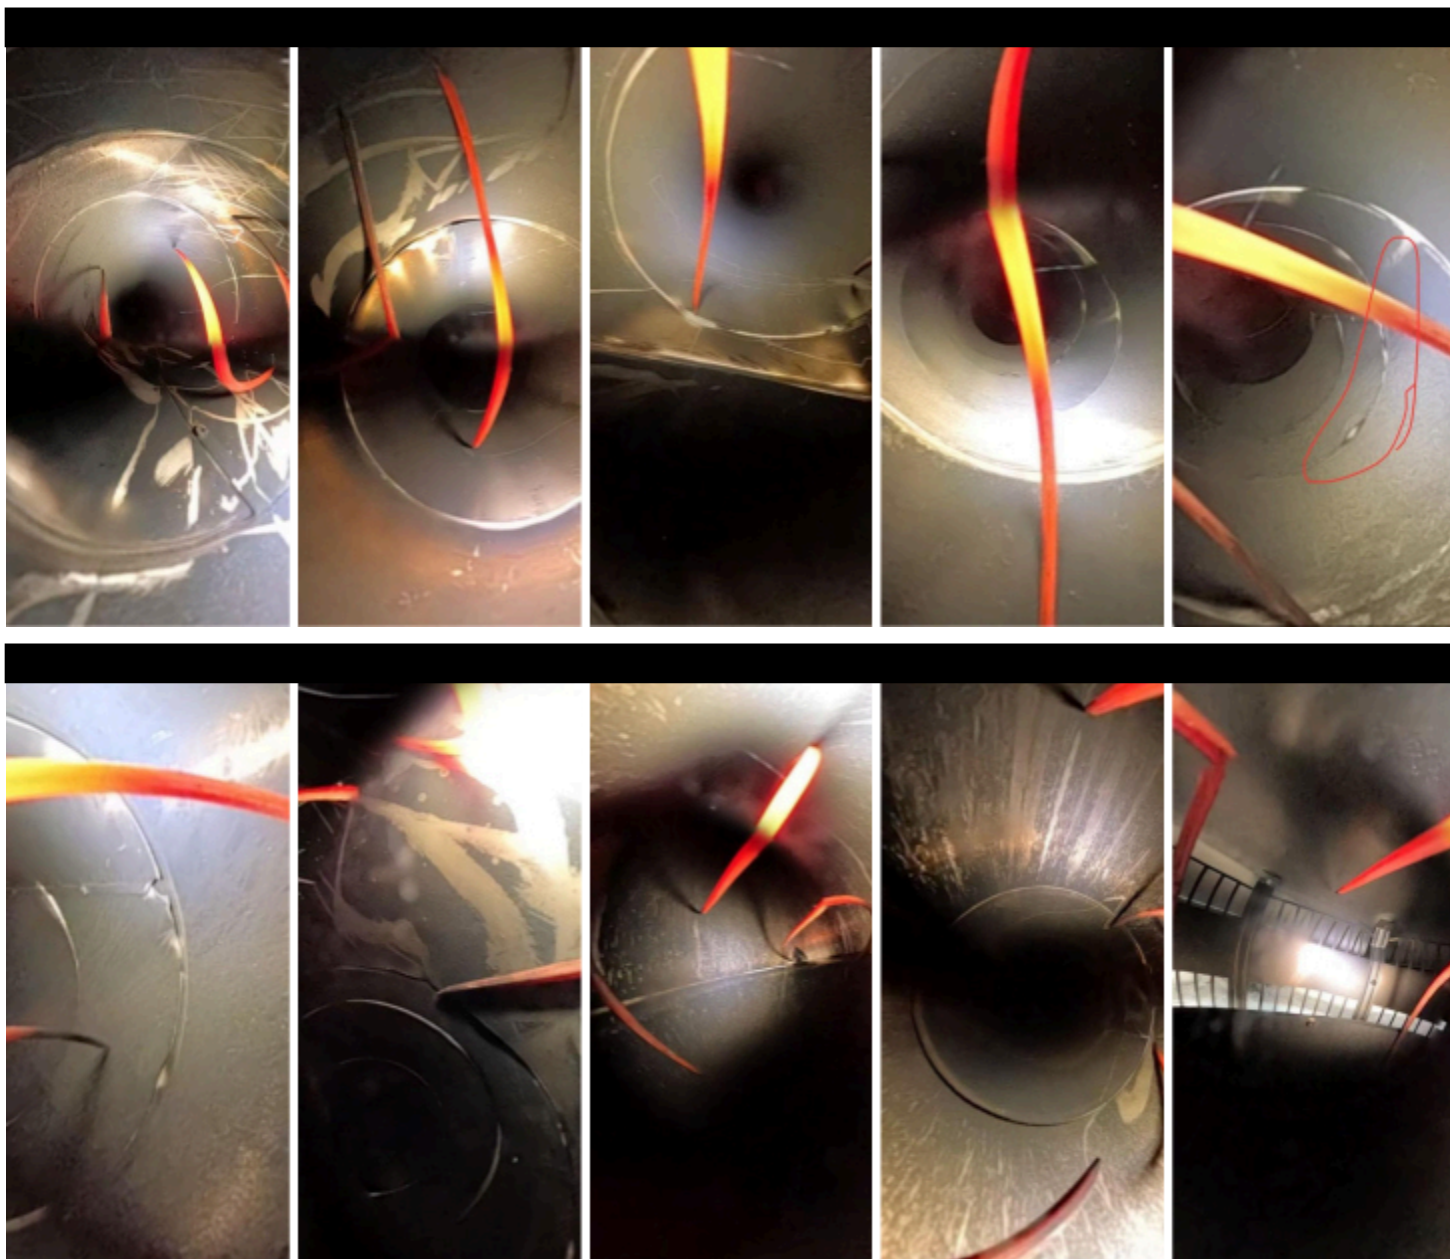
#### 5.21. Lower Level Family Room – Factory Built Flue Interior – **Deficiencies Noted**

**Deficiencies noted:** Damaged/flared Seams, Seam Irregularities.

**Explanation:** Factory-built chimney and vent components must remain free of damage, corrosion, deformation, open or irregular seams, improper

conditions documented above were identified during the internal camera inspection performed as part of this Level II inspection. Where a listed chimney or vent component is damaged or improperly assembled, corrective work should generally consist of replacement with the exact listed/approved component unless the manufacturer provides another specifically approved repair method.
